# Access Compliance Report

## Public Rights-of-Way

### (Curb Ramps)

Intersection ID: 10016945	Main Street: WINTERFIELD_PL	Cross Street: CAMPBELL_DR	Location: E
ADA ID: CE0F0D97F455	Ramp Type: Perp	Initial Pass/Fail: Fail	Overall Compliance: No
Severity Score: 12.5			
Codes/Mitigation Info/Possible Solution		Field Measurements/Component Compliance

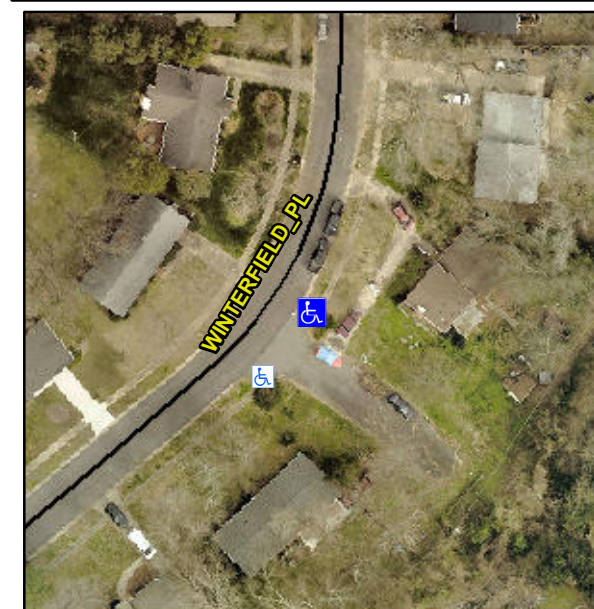
**Not Found, R304.5.3**

Compliance	Description	Data	Compliance	Description	Data
N/A	Ramp Length (in)	32.0	Yes	Ramp Slope (%)	5.2
Yes	Ramp Width (in)	48.0	No	Ramp XSlope (%)	6.6
N/A	Flare Type LT	N/A	N/A	Flare Type RT	N/A
N/A	Flare Slope LT (%)	N/A	N/A	Flare Slope RT (%)	N/A
N/A	Flare Traversable LT?	N/A	N/A	Flare Traversable RT?	N/A
N/A	Landing Length (in)	N/A	N/A	DWS Provided?	N/A
N/A	Landing Width (in)	N/A	N/A	DWS Contrast?	N/A
N/A	Landing Slope (%)	N/A	N/A	DWS Length (in)	N/A
N/A	Landing X Slope (%)	N/A	N/A	DWS Full Width?	N/A
N/A	Landing Curb? (Y/N)	N/A	N/A	DWS Offset (in)	N/A
N/A	Shared Landing?	N/A			
N/A	Gutter Ponding?	N/A	N/A	Gutter Slope (%)	N/A
N/A	Gutter Lip Ht (in)	N/A	N/A	Gutter X Slope (%)	N/A
N/A	Painted X Walk1?	No	N/A	Painted X Walk2?	N/A
	X Walk 1 Direction	To SW		X Walk 2 Direction	N/A
N/A	X Walk 1 Width (in)	N/A	N/A	X Walk 2 Width (in)	N/A
	X Walk 1 Slope (%)	0.6		X Walk 2 Slope (%)	N/A
	X Walk 1 X Slope (%)	7.8		X Walk 2 X Slope (%)	N/A

N/A	Ramp inside XWalk1?	N/A	N/A	Ramp inside XWalk2?	N/A
	Road Slope (%)	N/A	N/A	Clear Space?	N/A
	Road X Slope (%)	N/A	N/A	Clear Space to XWalk (in)	N/A
N/A	Any Obstructions?	N/A	N/A	Storm Grate/Utility Hazard?	N/A
	Obstruction Type			Storm Grate/Utility Type	
		N/A			N/A
		Yes		Surface Condition? (G/P)	Good

Possible Solutions:

**Remove & Replace Entire Ramp.**

Total Cost: \$ 1850.00
