Access Compliance Report Public Rights-of-Way (Curb Ramps)

Intersection ID: 52573 Main Street: NEW_RENAISSANCE_WY Cross Street: NOBLES_AV Location: NW **Overall Compliance: No ADA ID: CE22A59DB132** Ramp Type: Perp Initial Pass/Fail: Fail **Severity Score:** 12.5

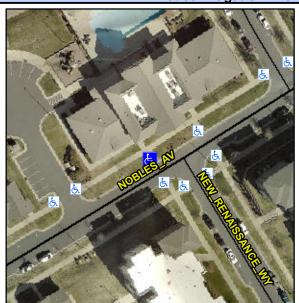
Field Measurements/Component Compliance						
Comp	liance Description	Data	Compli	ance	Description	Data
N/A	Ramp Length (in)	72.0	No	Ramp	Slope (%)	11.5
Yes	Ramp Width (in)	70.0	Yes	Ramp	XSlope (%)	0.5
N/A	Flare Type LT	N/A	N/A	Flare	Type RT	N/A
N/A	Flare Slope LT (%)	N/A	N/A	Flare	Slope RT (%)	N/A
N/A	Flare Traversable LT?	N/A	N/A	Flare	Traversable RT?	N/A
N/A	Landing Length (in)	N/A	N/A	DWS	Provided?	N/A
N/A	Landing Width (in)	N/A	N/A	DWS	Contrast?	N/A
N/A	Landing Slope (%)	N/A	N/A	DWS	Length (in)	N/A
N/A	Landing X Slope (%)	N/A	N/A	DWS	Full Width?	N/A
N/A	Landing Curb? (Y/N)	N/A	N/A	DWS	Offset (in)	N/A
N/A	Shared Landing?	N/A				
N/A	Gutter Ponding?	N/A	N/A	Gutte	r Slope (%)	N/A
N/A	Gutter Lip Ht (in)	N/A	N/A	Gutte	er X Slope (%)	N/A
N/A	Painted X Walk1?	No	N/A	Paint	ed X Walk2?	N/A
	X Walk 1 Direction	To S		X Wa	lk 2 Direction	N/A
N/A	X Walk 1 Width (in)	N/A	N/A	X Wa	lk 2 Width (in)	N/A
	X Walk 1 Slope (%)	3.6		X Wa	lk 2 Slope (%)	N/A

Possible Solutions:					
Remove & Replace Entire Ramp.					
Surveyor Notes:					
N/A					
PROW/ADA:					
R304.2.2
