Access Compliance Report

Public Rights-of-Way

(Curb Ramps)

Intersection ID: N/A	Main Street: BROOKSVALE_ST	Cross Street: N/A	Location: SW
ADA ID: CE2AF572AA65	Ramp Type: Perp	Initial Pass/Fail: Fail	Overall Compliance: No
Severity Score: 12.5			
Codes/Mitigation Info/Possible Solution		Field Measurements/Component Compliance

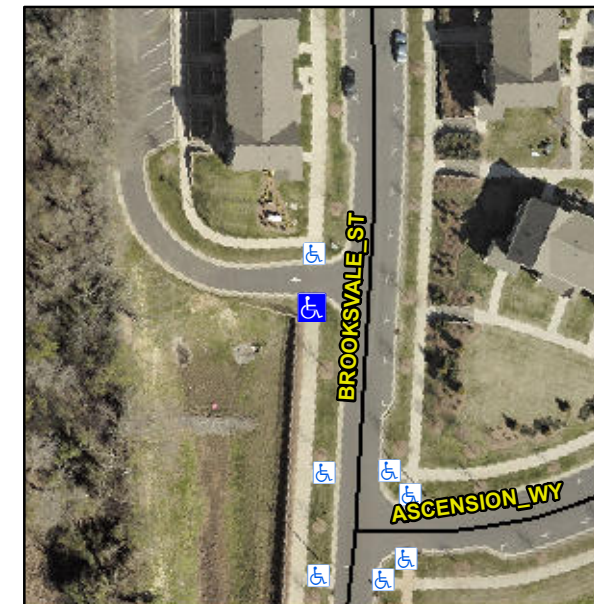
R304.2.2

Compliance	Description	Data	Compliance	Description	Data
N/A	Ramp Length (in)	72.0	No	Ramp Slope (%)	8.5
Yes	Ramp Width (in)	94.0	Yes	Ramp XSlope (%)	0.2
N/A	Flare Type LT	N/A	N/A	Flare Type RT	N/A
N/A	Flare Slope LT (%)	N/A	N/A	Flare Slope RT (%)	N/A
N/A	Flare Traversable LT?	N/A	N/A	Flare Traversable RT?	N/A
N/A	Landing Length (in)	N/A	N/A	DWS Provided?	N/A
N/A	Landing Width (in)	N/A	N/A	DWS Contrast?	N/A
N/A	Landing Slope (%)	N/A	N/A	DWS Length (in)	N/A
N/A	Landing X Slope (%)	N/A	N/A	DWS Full Width?	N/A
N/A	Landing Curb? (Y/N)	N/A	N/A	DWS Offset (in)	N/A
N/A	Shared Landing?	N/A			
N/A	Gutter Ponding?	N/A	N/A	Gutter Slope (%)	N/A
N/A	Gutter Lip Ht (in)	N/A	N/A	Gutter X Slope (%)	N/A
N/A	Painted X Walk1?	No	N/A	Painted X Walk2?	N/A
	X Walk 1 Direction	To N		X Walk 2 Direction	N/A
N/A	X Walk 1 Width (in)	N/A	N/A	X Walk 2 Width (in)	N/A
	X Walk 1 Slope (%)	1.9		X Walk 2 Slope (%)	N/A
	X Walk 1 X Slope (%)	0.8		X Walk 2 X Slope (%)	N/A

Remove & Replace Entire Ramp.
