Access Compliance Report Public Rights-of-Way (Curb Ramps)

Intersection ID: 10384 Main Street: E_34TH_ST Cross Street: N_MYERS_ST Location: E

ADA ID: CE2CBCB165B0 Ramp Type: Perp Initial Pass/Fail: Fail Overall Compliance: No Severity Score: 8.75

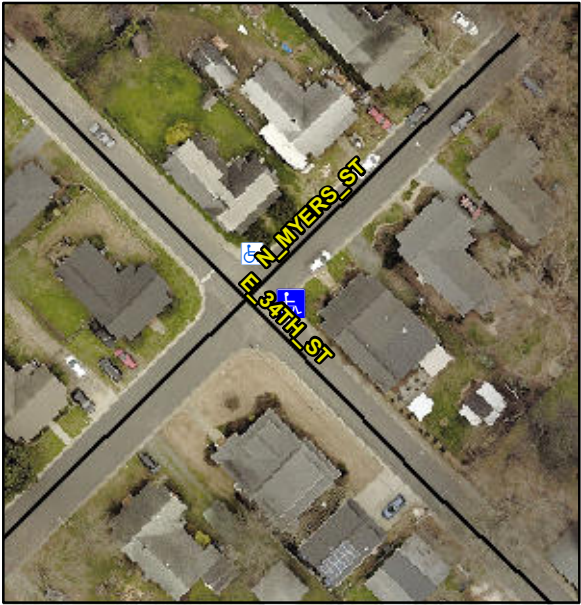
PROW/ADA:
Not Found, R304.5.1

Compliance	Description	Data	Compliance	Description	Data
N/A	Ramp Length (in)	54.0	Yes	Ramp Slope (%)	5.3
No	Ramp Width (in)	42.0	Yes	Ramp XSlope (%)	0.5
N/A	Flare Type LT	N/A	N/A	Flare Type RT	N/A
N/A	Flare Slope LT (%)	N/A	N/A	Flare Slope RT (%)	N/A
N/A	Flare Traversable LT?	N/A	N/A	Flare Traversable RT?	N/A
N/A	Landing Length (in)	N/A	N/A	DWS Provided?	N/A
N/A	Landing Width (in)	N/A	N/A	DWS Contrast?	N/A
N/A	Landing Slope (%)	N/A	N/A	DWS Length (in)	N/A
N/A	Landing X Slope (%)	N/A	N/A	DWS Full Width?	N/A
N/A	Landing Curb? (Y/N)	N/A	N/A	DWS Offset (in)	N/A
N/A	Shared Landing?	N/A			
N/A	Gutter Ponding?	N/A	N/A	Gutter Slope (%)	N/A
N/A	Gutter Lip Ht (in)	N/A	N/A	Gutter X Slope (%)	N/A
N/A	Painted X Walk1?	No	N/A	Painted X Walk2?	N/A
	X Walk 1 Direction	To NW		X Walk 2 Direction	N/A
N/A	X Walk 1 Width (in)	N/A	N/A	X Walk 2 Width (in)	N/A
	X Walk 1 Slope (%)	1.3		X Walk 2 Slope (%)	N/A
	X Walk 1 X Slope (%)	3.3		X Walk 2 X Slope (%)	N/A

N/A	Ramp inside XWalk1?	N/A	N/A	Ramp inside XWalk2?	N/A
	Road Slope (%)	N/A	N/A	Clear Space?	N/A
	Road X Slope (%)	N/A	N/A	Clear Space to XWalk (in)	N/A
N/A	Any Obstructions?	N/A	N/A	Storm Grate/Utility Hazard?	N/A
	Obstruction Type			Storm Grate/Utility Type	
		N/A			N/A
			Yes	Surface Condition? (G/P)	Good

Possible Solutions:
Remove & Replace Entire Ramp.
