# Access Compliance Report

## Public Rights-of-Way

| Intersection ID: 11207 | Main Street: GRANDIN_RD | Cross Street: W_4TH_ST | Location: | N |
| ADA ID: CE3002F48519 | Ramp Type: BlendTrans1 | Initial Pass/Fail: Fail | Overall Compliance: No | Severity Score: 10 |

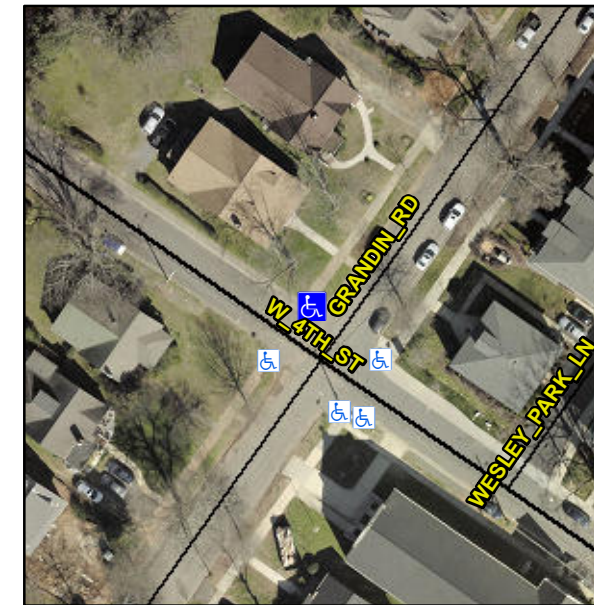
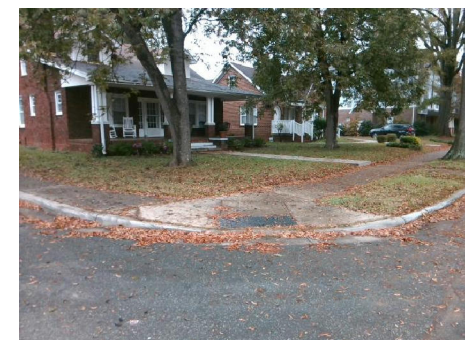
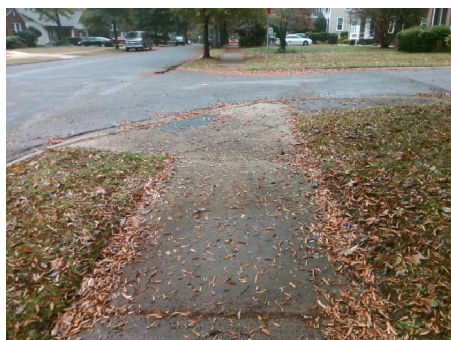
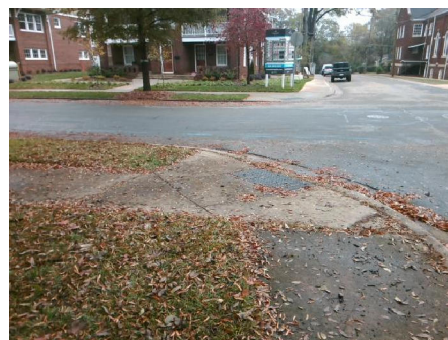
**Not Found, R304.5.1, R304.5.3**

| Compliance | Description | Data | Compliance | Description | Data |
|---|---|---|---|---|---|
| No | Ramp Width (in) | 47.5 | No | BlendTrans XSlope (%) | 3.9 |
| | | | No | Curb Slope (%) | 25.8 |

**Remove & Replace Curb Ramp With Two New Directional Ramps or Equivalent.**
