Access Compliance Report

Public Rights-of-Way

(Curb Ramps)

Intersection ID: 15548	Main Street: HEMLOCK_ST	Cross Street: SCOTT_AV	Location: S
ADA ID: CE3519070C69	Ramp Type: Directional1	Initial Pass/Fail: Fail	Overall Compliance: No
		Severity Score: 8.75

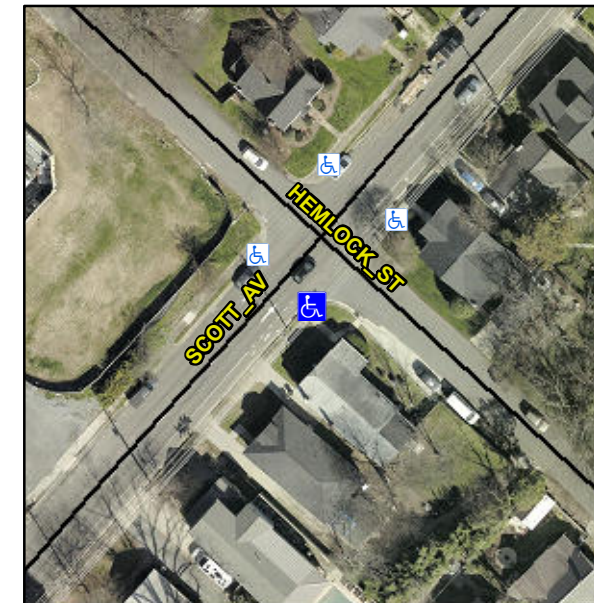
Compliance	Description	Data	Compliance	Description	Data
N/A	Ramp Length (in)	47.0	N/A	Grade Break?	N/A
No	Ramp Width (in)	39.0	N/A	Grade Break Slope (%)	0.0
Yes	Ramp Slope (%)	4.3	N/A	Grade Break XSlope (%)	0.0
Yes	Ramp XSlope (%)	1.9			
N/A	Flare Type LT	N/A	N/A	Flare Type RT	N/A
N/A	Flare Slope LT (%)	N/A	N/A	Flare Slope RT (%)	0.0
N/A	Flare Traversable LT?	N/A	N/A	Flare Traversable RT?	N/A
N/A	Landing Length (in)	0.0	N/A	DWS Provided?	N/A
N/A	Landing Width (in)	0.0	N/A	DWS Contrast?	N/A
N/A	Landing Slope (%)	0.0	N/A	DWS Length (in)	N/A
N/A	Landing X Slope (%)	0.0	N/A	DWS Full Width?	N/A
N/A	Landing Curb? (Y/N)	N/A	N/A	DWS Offset LT (in)	N/A
N/A	Shared Landing?	N/A	N/A	DWS Offset RT (in)	N/A
N/A	Gutter Ponding?	0.0	N/A	Gutter Slope (%)	N/A
N/A	Gutter Lip Ht (in)	0.0	N/A	Gutter X Slope (%)	N/A
N/A	Painted X Walk1?	No		Road Slope (%)	4.9
	X Walk 1 Direction	To NE		Road X Slope (%)	2.8
	X Walk 1 Width (in)	N/A		Clear Space?	N/A

X Walk 1 Slope (%)	4.9	N/A	Clear Space to XWalk (in)	N/A
	X Walk 1 X Slope (%)	2.8	N/A	Storm Grate/Utility Hazard?	N/A
N/A	Ramp inside XWalk1?	N/A		Storm Grate/Utility Type	
N/A	Any Obstructions?	N/A			N/A
	Obstruction Type		Yes	Surface Condition? (G/P)	Good
			N/A	Curb Slope (%)	8.7

Possible Solutions:

Remove & Replace Entire Ramp.
