# Access Compliance Report

## Public Rights-of-Way

### (Curb Ramps)

Intersection ID: 52931	Main Street: WALTHAM_LN	Cross Street: GRAY_OAK_LN	Location: E
ADA ID: CE38959105B1	Ramp Type: Perp	Initial Pass/Fail: Fail	Overall Compliance: No
Severity Score: 21.25			
Codes/Mitigation Info/Possible Solution		Field Measurements/Component Compliance

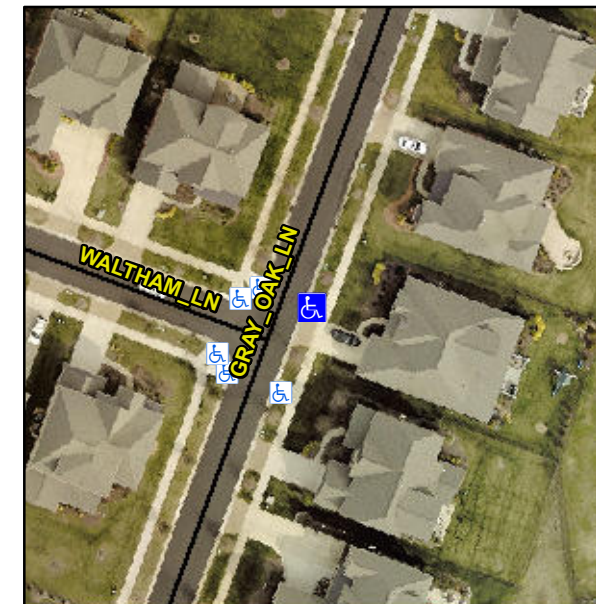
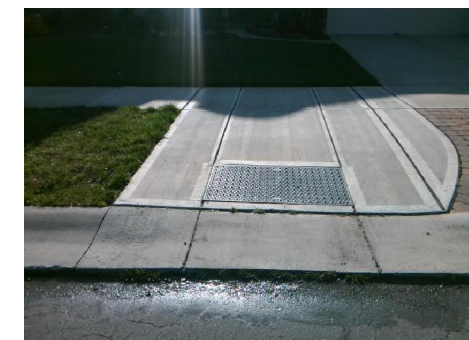
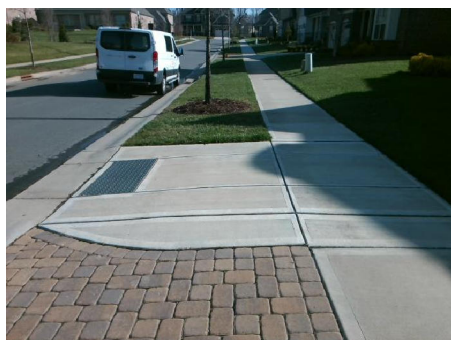
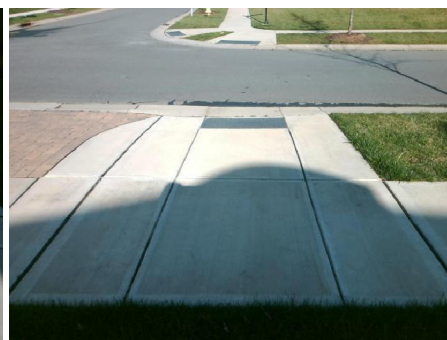
**Not Found, R304.5.1, R304.2.2**

Compliance	Description	Data	Compliance	Description	Data
N/A	Ramp Length (in)	95.0	No	Ramp Slope (%)	9.6
No	Ramp Width (in)	47.0	Yes	Ramp XSlope (%)	0.6
N/A	Flare Type LT	N/A	N/A	Flare Type RT	N/A
N/A	Flare Slope LT (%)	N/A	N/A	Flare Slope RT (%)	N/A
N/A	Flare Traversable LT?	N/A	N/A	Flare Traversable RT?	N/A
N/A	Landing Length (in)	N/A	N/A	DWS Provided?	N/A
N/A	Landing Width (in)	N/A	N/A	DWS Contrast?	N/A
N/A	Landing Slope (%)	N/A	N/A	DWS Length (in)	N/A
N/A	Landing X Slope (%)	N/A	N/A	DWS Full Width?	N/A
N/A	Landing Curb? (Y/N)	N/A	N/A	DWS Offset (in)	N/A
N/A	Shared Landing?	N/A			
N/A	Gutter Ponding?	N/A	N/A	Gutter Slope (%)	N/A
N/A	Gutter Lip Ht (in)	N/A	N/A	Gutter X Slope (%)	N/A
N/A	Painted X Walk1?	No	N/A	Painted X Walk2?	N/A
	X Walk 1 Direction	To NW		X Walk 2 Direction	N/A
N/A	X Walk 1 Width (in)	N/A	N/A	X Walk 2 Width (in)	N/A
	X Walk 1 Slope (%)	3.8		X Walk 2 Slope (%)	N/A
	X Walk 1 X Slope (%)	2.6		X Walk 2 X Slope (%)	N/A

N/A	Ramp inside XWalk1?	N/A	N/A	Ramp inside XWalk2?	N/A
	Road Slope (%)	N/A	N/A	Clear Space?	N/A
	Road X Slope (%)	N/A	N/A	Clear Space to XWalk (in)	N/A
N/A	Any Obstructions?	N/A	N/A	Storm Grate/Utility Hazard?	N/A
	Obstruction Type			Storm Grate/Utility Type	
		N/A			N/A
			Yes	Surface Condition? (G/P)	Good

**Remove & Replace Entire Ramp.**

Total Cost: \$ 1850.00
