# Access Compliance Report

## Public Rights-of-Way

### (Curb Ramps)

| Intersection ID: 2755 | Main Street: BELL'S_MILL_DR | Cross Street: RIDGEFIELD_DR | Location: E |

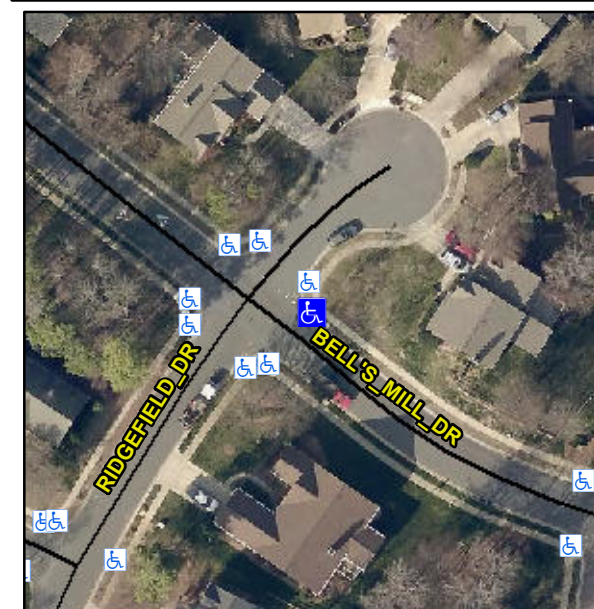
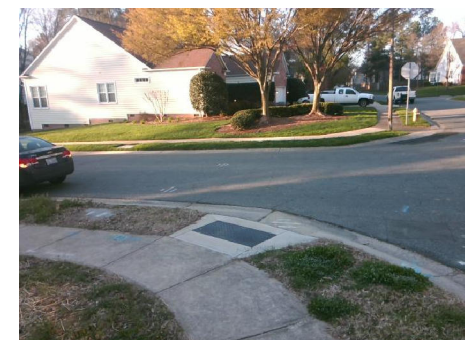
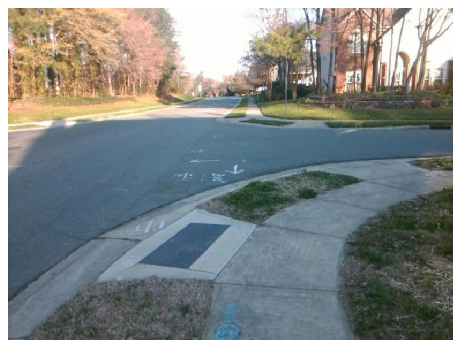
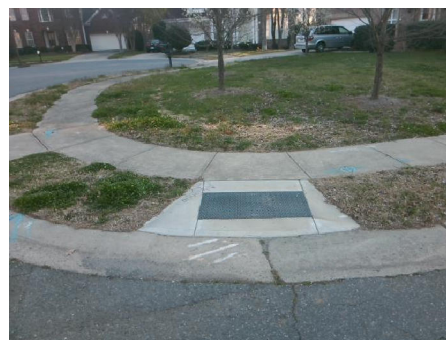
| ADA ID: CE4A431754CB | Ramp Type: BlendTrans1 | Initial Pass/Fail: Pass | Overall Compliance: No |
| | | | Severity Score: 14.25 |

**Not Found, R304.2.1, R304.5.3, R305.1.4, R305.2, R302.7.2**

| Compliance | Description | Data | Compliance | Description | Data |
|---|---|---|---|---|---|
| No | Landing Length (in) | 46.0 | Yes | DWS Provided? | Yes |
| No | Landing Width (in) | 43.0 | Yes | DWS Contrast? | Yes |
| No | Landing X Slope (%) | 5.4 | No | DWS Full Width? | No |
| N/A | Landing Curb? (Y/N) | No | No | DWS Offset (in) | 13.0 |
| No | Gutter Lip Ht (in) | 0.3 | Yes | Gutter X Slope (%) | 0.6 |
| | | | No | Curb Slope (%) | 8.5 |

**Remove & Replace Curb Ramp With Two New Directional Ramps or Equivalent.**

Total Cost: \$ 3200.00
