Access Compliance Report

Public Rights-of-Way (Curb Ramps)

Intersection ID: 10040511	Main Street: W_4TH_ST	Cross Street: N/A	Location: SE
ADA ID: CE5416A143A7	Ramp Type: Directional2	Initial Pass/Fail: Fail	Overall Compliance: No
		Severity Score: 25

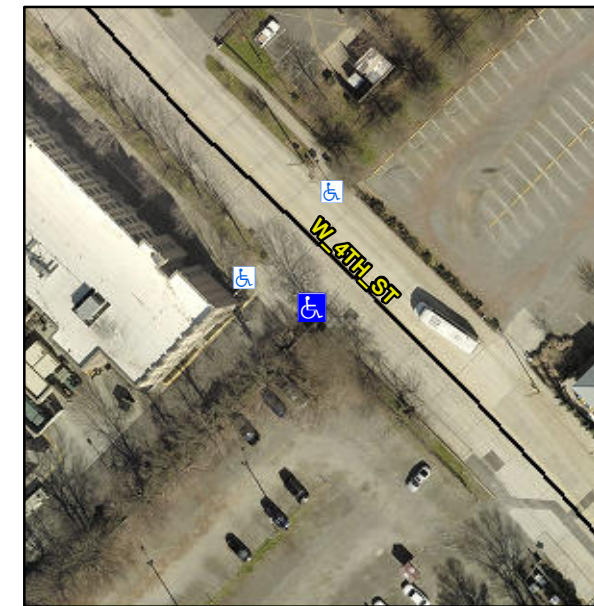
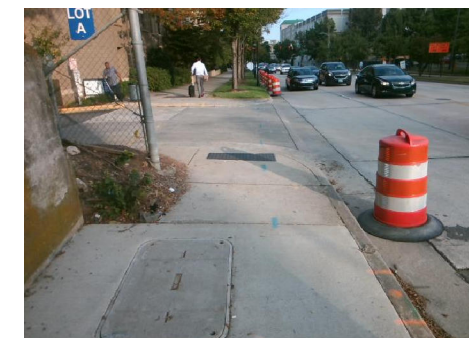
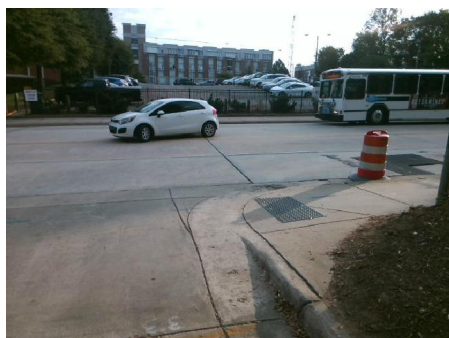
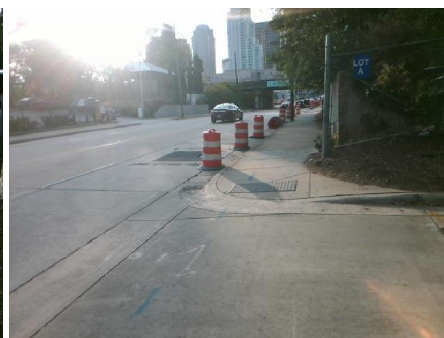
R304.2.2, R304.5.3

Compliance	Description	Data	Compliance	Description	Data
N/A	Ramp Length (in)	72.0	N/A	Grade Break?	N/A
Yes	Ramp Width (in)	60.0	N/A	Grade Break Slope (%)	0.0
No	Ramp Slope (%)	8.9	N/A	Grade Break XSlope (%)	0.0
No	Ramp XSlope (%)	5.6			
N/A	Flare Type LT	N/A	N/A	Flare Type RT	N/A
N/A	Flare Slope LT (%)	N/A	N/A	Flare Slope RT (%)	0.0
N/A	Flare Traversable LT?	N/A	N/A	Flare Traversable RT?	N/A
N/A	Landing Length (in)	0.0	N/A	DWS Provided?	N/A
N/A	Landing Width (in)	0.0	N/A	DWS Contrast?	N/A
N/A	Landing Slope (%)	0.0	N/A	DWS Length (in)	N/A
N/A	Landing X Slope (%)	0.0	N/A	DWS Full Width?	N/A
N/A	Landing Curb? (Y/N)	N/A	N/A	DWS Offset LT (in)	N/A
N/A	Shared Landing?	N/A	N/A	DWS Offset RT (in)	N/A
N/A	Gutter Ponding?	0.0	N/A	Gutter Slope (%)	N/A
N/A	Gutter Lip Ht (in)	0.0	N/A	Gutter X Slope (%)	N/A
N/A	Painted X Walk1?	No		Road Slope (%)	3.0
	X Walk 1 Direction	To NW		Road X Slope (%)	4.8
	X Walk 1 Width (in)	N/A		Clear Space?	N/A

X Walk 1 Slope (%)	3.0	N/A	Clear Space to XWalk (in)	N/A
	X Walk 1 X Slope (%)	4.8	N/A	Storm Grate/Utility Hazard?	N/A
N/A	Ramp inside XWalk1?	N/A		Storm Grate/Utility Type	
N/A	Any Obstructions?	N/A			N/A
	Obstruction Type		Yes	Surface Condition? (G/P)	Good
			N/A	Curb Slope (%)	1.6

Remove & Replace Entire Ramp.
