Access Compliance Report

Public Rights-of-Way

(Curb Ramps)

Intersection ID: 28499	Main Street: BIRD_WATCH_LN	Cross Street: NORTHWOODS_FOREST_DR	Location: E
ADA ID: CE5555EB0BC5	Ramp Type: BlendTrans2	Initial Pass/Fail: Fail	Overall Compliance: No
		Severity Score: 17.5

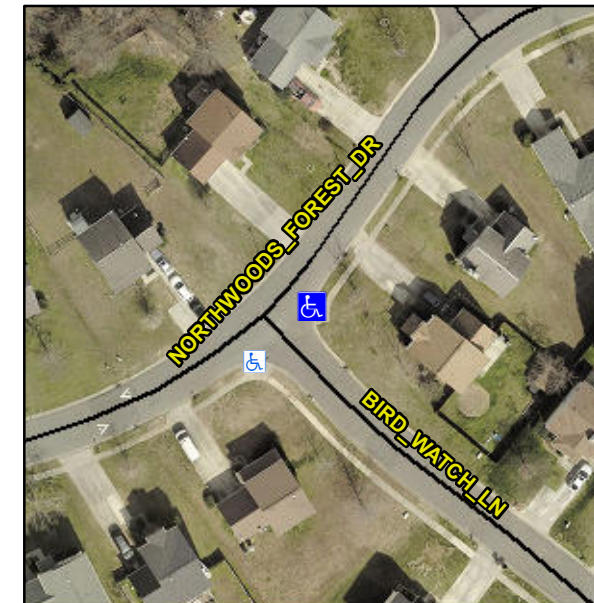
Compliance	Description	Data	Compliance	Description	Data
N/A	Ramp Length (in)	93.0	Yes	BlendTrans Slope (%)	4.4
No	Ramp Width (in)	33.0	Yes	BlendTrans XSlope (%)	0.2
N/A	Flare Type LT	N/A	N/A	Flare Type RT	N/A
N/A	Flare Slope LT (%)	N/A	N/A	Flare Slope RT (%)	N/A
N/A	Flare Traversable LT?	N/A	N/A	Flare Traversable RT?	N/A
N/A	Landing Length (in)	N/A	N/A	DWS Provided?	N/A
N/A	Landing Width (in)	N/A	N/A	DWS Contrast?	N/A
N/A	Landing Slope (%)	N/A	N/A	DWS Length (in)	N/A
N/A	Landing X Slope (%)	N/A	N/A	DWS Full Width?	N/A
N/A	Landing Curb? (Y/N)	N/A	N/A	DWS Offset (in)	N/A
N/A	Shared Landing?	N/A			
N/A	Gutter Ponding?	N/A	N/A	Gutter Slope (%)	N/A
N/A	Gutter Lip Ht (in)	N/A	N/A	Gutter X Slope (%)	N/A
N/A	Painted X Walk1?	No	N/A	Painted X Walk2?	N/A
	X Walk 1 Direction	To SW		X Walk 2 Direction	N/A
	X Walk 1 Width (in)	N/A		X Walk 2 Width (in)	N/A
	X Walk 1 Slope (%)	0.3		X Walk 2 Slope (%)	N/A
	X Walk 1 X Slope (%)	2.0		X Walk 2 X Slope (%)	N/A

N/A	Ramp inside XWalk1?	N/A	N/A	Ramp inside XWalk2?	N/A
	Road Slope (%)	2.0		Clear Space?	N/A
	Road X Slope (%)	0.3	N/A	Clear Space to XWalk (in)	N/A
N/A	Any Obstructions?	N/A	N/A	Storm Grate/Utility Hazard?	N/A
	Obstruction Type			Storm Grate/Utility Type	
		N/A			N/A
			Yes	Surface Condition? (G/P)	Good
			No	Curb Slope (%)	19.0

Remove & Replace Curb Ramp With Two New Directional Ramps or Equivalent.

Not Found, R304.5.1
