Access Compliance Report Public Rights-of-Way (Curb Ramps)

Intersection ID: 14998 Main Street: DUNN_AV Cross Street: GENE_AV Location: NE

ADA ID: CE5AF14406FF Ramp Type: Para Initial Pass/Fail: Fail Overall Compliance: No Severity Score: 13.75

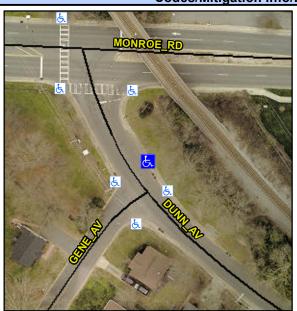
LT RP < 5%

R304.3.2, R304.5.3

Field Measurements/Component Compliance Compliance Description Data Compliance Description Data					
N/A	Ramp Length LT (in)	71.0	N/A	Ramp Length RT (in)	71.0
Yes	Ramp Width LT (in)	59.0	Yes	Ramp Width RT (in)	59.0
Yes	Ramp Slope LT (%)	0.5	No	Ramp Slope RT (%)	10.4
Yes	Ramp XSlope LT (%)	2.0	No	Ramp XSlope RT (%)	3.9
N/A	Landing Length (in)	N/A	N/A	DWS Provided?	N/A
N/A	Landing Width (in)	N/A	N/A	DWS Contrast?	N/A
N/A	Landing Slope (%)	N/A	N/A	DWS Length (in)	N/A
N/A	Landing X Slope (%)	N/A	N/A	DWS Full Width?	N/A
N/A	Landing Curb? (Y/N)	N/A	N/A	DWS Offset (in)	N/A
N/A	Shared Landing?	N/A	IV/A	DVVO Oliset (III)	N/A
N/A	Gutter Ponding?	N/A	N/A	Gutter Slope (%)	N/A
N/A	Gutter Lip Ht (in)	2.0	N/A	Gutter X Slope (%)	N/A
N/A	Painted X Walk1?	No.	N/A	Painted X Walk2?	N/A
IV/A	X Walk 1 Direction	To SW	IV/A	X Walk 2 Direction	N/A
N/A	X Walk 1 Width (in)	N/A	N/A	X Walk 2 Width (in)	N/A
10/74	X Walk 1 Slope (%)	2.0	I WA	X Walk 2 Slope (%)	N/A

Remove & Replace Entire Ramp.

Total Cost: \$ 1600.00
