Access Compliance Report Public Rights-of-Way (Curb Ramps)

Intersection ID: 42965	ntersection ID: 42965 Main Street: RED_ROBIN_ST		Cross	Street:	QUAIL_ST	Location:	NW		
ADA ID: CE5BBCB3CC8E Ramp Type: PerpDiag		Initial F	Initial Pass/Fail: Pass Overall Compliance: No				o Severity Score:	10.25	
Codes/Mitigation Info/Possible Solution				Field Measurements/Component Compliance					
	PI	Possible Solutions:		Compliance Description D			Comp	Data	
RED ROCEN DT - LA ST	5	Remove & Replace Curb Ramp	With	N/A	Ramp Length (in)	47.5	Yes	Ramp Slope (%)	7.7
		Two New Directional Ramps or Equivalent.		Yes	Ramp Width (in)	48.0	No	Ramp XSlope (%)	2.3
				N/A	Flare Type LT	Sloped	N/A	Flare Type RT	N/A

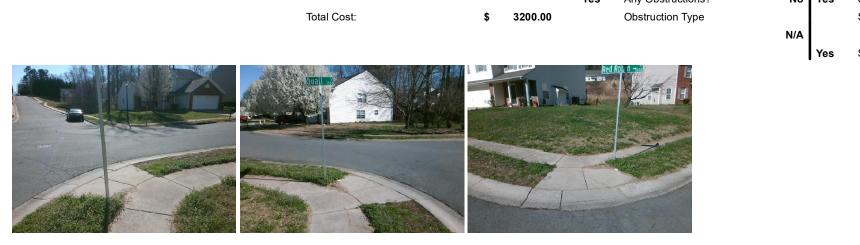
-		N/A	Flare Slope LT (%)	6.4	Yes	Flare Slope RT (%)	3.2
				N/A	Flare Traversable LT?	Yes	N/A	Flare Traversable RT?	Yes
				Yes	Landing Length (in)	48.0	No	DWS Provided?	No
		Surveyor Notes:		Yes	Landing Width (in)	48.0	N/A	DWS Contrast?	No
		N/A		Yes	Landing Slope (%)	1.4	N/A	DWS Length (in)	N/A
				No	Landing X Slope (%)	3.8	N/A	DWS Full Width?	No
the terms				N/A	Landing Curb? (Y/N)	No	N/A	DWS Offset (in)	N/A
				N/A	Shared Landing?	No			
A CAME I FARM		PROW/ADA:		Yes	Gutter Ponding?	No	Yes	Gutter Slope (%)	2.6
		Not Found, R304.5.3, R305		Yes	Gutter Lip Ht (in)	0.0	Yes	Gutter X Slope (%)	1.3
The West of the second		,,,		N/A	Painted X Walk1?	No	N/A	Painted X Walk2?	No
the bar of the second					X Walk 1 Direction	To SW		X Walk 2 Direction	To SE
	and the second			N/A	X Walk 1 Width (in)	N/A	N/A	X Walk 2 Width (in)	N/A
Street 1 Name	RED ROBIN ST				X Walk 1 Slope (%)	2.4		X Walk 2 Slope (%)	0.9
Stop Condition-Street 2	StopSign				X Walk 1 X Slope (%)	0.6		X Walk 2 X Slope (%)	1.6

Street 2 Name	QUAIL ST			N/A	Ramp inside XWalk1?	N/A	N/A	Ramp inside XWalk2?	N/A
Stop Condition-Street 1	None				Road Slope (%)	1.7	N/A	Clear Space?	Yes
					Road X Slope (%)	2.5	N/A	Clear Space to XWalk (in)	N/A
				Yes	Any Obstructions?	No	Yes	Storm Grate/Utility Hazard?	No
		Total Cost: \$	3200.00		Obstruction Type			Storm Grate/Utility Type	
						N/A			N/A
