# Access Compliance Report

## Public Rights-of-Way

### (Curb Ramps)

Intersection ID: 11597	Main Street: E_20TH_ST	Cross Street: SEIGLE_AV	Location: E
ADA ID: CE5C8BFB8E95	Ramp Type: Perp	Initial Pass/Fail: Fail	Overall Compliance: No
Severity Score: 13.75			
Codes/Mitigation Info/Possible Solution		Field Measurements/Component Compliance

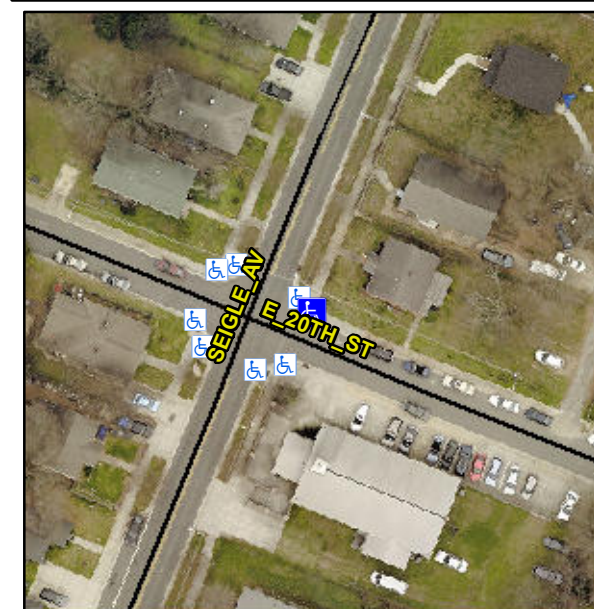
**Not Found, R304.2.2, R304.5.3**

Compliance	Description	Data	Compliance	Description	Data
N/A	Ramp Length (in)	55.5	No	Ramp Slope (%)	11.5
Yes	Ramp Width (in)	48.0	No	Ramp XSlope (%)	2.2
N/A	Flare Type LT	N/A	N/A	Flare Type RT	N/A
N/A	Flare Slope LT (%)	N/A	N/A	Flare Slope RT (%)	N/A
N/A	Flare Traversable LT?	N/A	N/A	Flare Traversable RT?	N/A
N/A	Landing Length (in)	N/A	N/A	DWS Provided?	N/A
N/A	Landing Width (in)	N/A	N/A	DWS Contrast?	N/A
N/A	Landing Slope (%)	N/A	N/A	DWS Length (in)	N/A
N/A	Landing X Slope (%)	N/A	N/A	DWS Full Width?	N/A
N/A	Landing Curb? (Y/N)	N/A	N/A	DWS Offset (in)	N/A
N/A	Shared Landing?	N/A			
N/A	Gutter Ponding?	N/A	N/A	Gutter Slope (%)	N/A
N/A	Gutter Lip Ht (in)	N/A	N/A	Gutter X Slope (%)	N/A
N/A	Painted X Walk1?	No	N/A	Painted X Walk2?	N/A
	X Walk 1 Direction	To SW		X Walk 2 Direction	N/A
N/A	X Walk 1 Width (in)	N/A	N/A	X Walk 2 Width (in)	N/A
	X Walk 1 Slope (%)	6.2		X Walk 2 Slope (%)	N/A
	X Walk 1 X Slope (%)	0.6		X Walk 2 X Slope (%)	N/A

N/A	Ramp inside XWalk1?	N/A	N/A	Ramp inside XWalk2?	N/A
	Road Slope (%)	N/A	N/A	Clear Space?	N/A
	Road X Slope (%)	N/A	N/A	Clear Space to XWalk (in)	N/A
N/A	Any Obstructions?	N/A	N/A	Storm Grate/Utility Hazard?	N/A
	Obstruction Type			Storm Grate/Utility Type	
		N/A			N/A
			Yes	Surface Condition? (G/P)	Good

**Remove & Replace Entire Ramp.**

Total Cost: \$ 1850.00
