Access Compliance Report

Public Rights-of-Way

(Curb Ramps)

Intersection ID: 9489	Main Street: STATESVILLE_AV	Cross Street: KOHLER_AV	Location: SW
ADA ID: CE5FA0B4521D	Ramp Type: Perp	Initial Pass/Fail: Fail	Overall Compliance: No
		Severity Score: 8.75

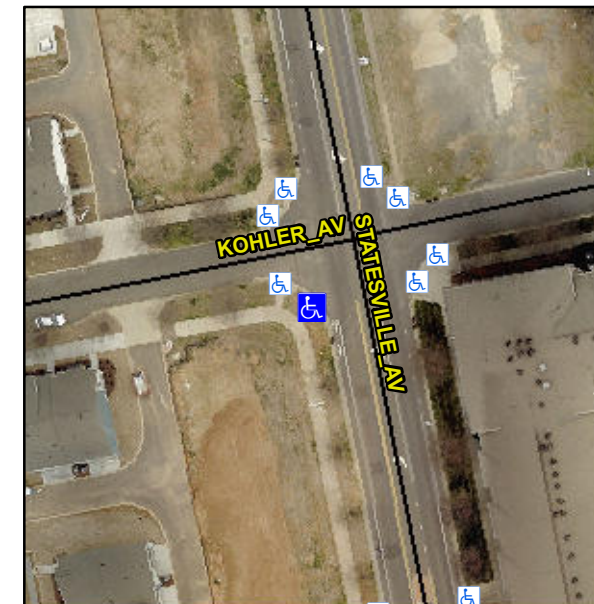
Not Found, R304.5.1

Compliance	Description	Data	Compliance	Description	Data
N/A	Ramp Length (in)	74.0	Yes	Ramp Slope (%)	7.5
No	Ramp Width (in)	46.5	Yes	Ramp XSlope (%)	0.6
N/A	Flare Type LT	N/A	N/A	Flare Type RT	N/A
N/A	Flare Slope LT (%)	N/A	N/A	Flare Slope RT (%)	N/A
N/A	Flare Traversable LT?	N/A	N/A	Flare Traversable RT?	N/A
N/A	Landing Length (in)	N/A	N/A	DWS Provided?	N/A
N/A	Landing Width (in)	N/A	N/A	DWS Contrast?	N/A
N/A	Landing Slope (%)	N/A	N/A	DWS Length (in)	N/A
N/A	Landing X Slope (%)	N/A	N/A	DWS Full Width?	N/A
N/A	Landing Curb? (Y/N)	N/A	N/A	DWS Offset (in)	N/A
N/A	Shared Landing?	N/A			
N/A	Gutter Ponding?	N/A	N/A	Gutter Slope (%)	N/A
N/A	Gutter Lip Ht (in)	N/A	N/A	Gutter X Slope (%)	N/A
N/A	Painted X Walk1?	No	N/A	Painted X Walk2?	N/A
	X Walk 1 Direction	To E		X Walk 2 Direction	N/A
N/A	X Walk 1 Width (in)	N/A	N/A	X Walk 2 Width (in)	N/A
	X Walk 1 Slope (%)	5.0		X Walk 2 Slope (%)	N/A
	X Walk 1 X Slope (%)	1.8		X Walk 2 X Slope (%)	N/A

N/A	Ramp inside XWalk1?	N/A	N/A	Ramp inside XWalk2?	N/A
	Road Slope (%)	N/A	N/A	Clear Space?	N/A
	Road X Slope (%)	N/A	N/A	Clear Space to XWalk (in)	N/A
N/A	Any Obstructions?	N/A	N/A	Storm Grate/Utility Hazard?	N/A
	Obstruction Type			Storm Grate/Utility Type	
		N/A			N/A
			Yes	Surface Condition? (G/P)	Good

Remove & Replace Entire Ramp.
