# Access Compliance Report

## Public Rights-of-Way

Intersection ID: 2713	Main Street: CARDINAL_POINT_RD	Cross Street: WHITE_MIST_LN	Location: NW
ADA ID: CE6035D5A744	Ramp Type: BlendTrans2	Initial Pass/Fail: Fail	Overall Compliance: No
		Severity Score: 1.25

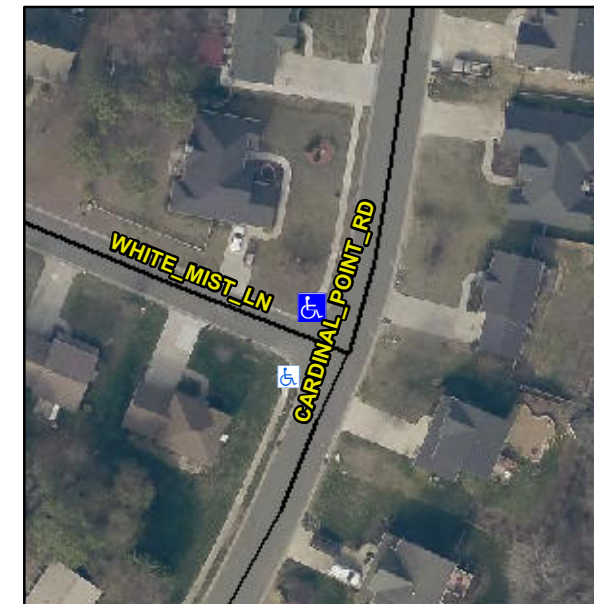
Compliance	Description	Data	Compliance	Description	Data
N/A	Ramp Length (in)	96.5	Yes	BlendTrans Slope (%)	3.2
Yes	Ramp Width (in)	59.0	No	BlendTrans XSlope (%)	3.0
N/A	Flare Type LT	N/A	N/A	Flare Type RT	N/A
N/A	Flare Slope LT (%)	N/A	N/A	Flare Slope RT (%)	N/A
N/A	Flare Traversable LT?	N/A	N/A	Flare Traversable RT?	N/A
N/A	Landing Length (in)	N/A	N/A	DWS Provided?	N/A
N/A	Landing Width (in)	N/A	N/A	DWS Contrast?	N/A
N/A	Landing Slope (%)	N/A	N/A	DWS Length (in)	N/A
N/A	Landing X Slope (%)	N/A	N/A	DWS Full Width?	N/A
N/A	Landing Curb? (Y/N)	N/A	N/A	DWS Offset (in)	N/A
N/A	Shared Landing?	N/A			
N/A	Gutter Ponding?	N/A	N/A	Gutter Slope (%)	N/A
N/A	Gutter Lip Ht (in)	N/A	N/A	Gutter X Slope (%)	N/A
N/A	Painted X Walk1?	No	N/A	Painted X Walk2?	N/A
	X Walk 1 Direction	To S		X Walk 2 Direction	N/A
	X Walk 1 Width (in)	N/A		X Walk 2 Width (in)	N/A
	X Walk 1 Slope (%)	1.6		X Walk 2 Slope (%)	N/A
	X Walk 1 X Slope (%)	3.3		X Walk 2 X Slope (%)	N/A

N/A	Ramp inside XWalk1?	N/A	N/A	Ramp inside XWalk2?	N/A
	Road Slope (%)	3.3		Clear Space?	N/A
	Road X Slope (%)	1.6	N/A	Clear Space to XWalk (in)	N/A
N/A	Any Obstructions?	N/A	N/A	Storm Grate/Utility Hazard?	N/A
	Obstruction Type			Storm Grate/Utility Type	
		N/A			N/A
			Yes	Surface Condition? (G/P)	Good
			No	Curb Slope (%)	11.2

**Remove & Replace Curb Ramp With Two New Directional Ramps or Equivalent.**
