Access Compliance Report Public Rights-of-Way (Curb Ramps)

Intersection ID: 11108 Main Street: TUCKASEEGEE_RD Cross Street: N/A Location: SE Severity Score: **Overall Compliance: No** ADA ID: CE643905C3F7 Ramp Type: Perp Initial Pass/Fail: Fail 8.75

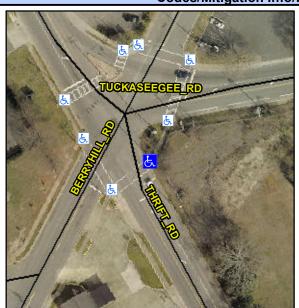
Field Measurements/Component Compliance								
Comp	liance Description	Data	Comp	liance	Description	Data		
N/A	Ramp Length (in)	60.0	Yes	Ramp	Slope (%)	6.2		
No	Ramp Width (in)	47.5	Yes	Ramp	XSlope (%)	1.5		
N/A	Flare Type LT	N/A	N/A	Flare Type RT		N/A		
N/A	Flare Slope LT (%)	N/A	N/A	Flare Slope RT (%)		N/A		
N/A	Flare Traversable LT?	N/A	N/A	Flare Traversable RT?		N/A		
N/A	Landing Length (in)	N/A	N/A	DWS	Provided?	N/A		
N/A	Landing Width (in)	N/A	N/A	DWS	Contrast?	N/A		
N/A	Landing Slope (%)	N/A	N/A	DWS	Length (in)	N/A		
N/A	Landing X Slope (%)	N/A	N/A	DWS	Full Width?	N/A		
N/A	Landing Curb? (Y/N)	N/A	N/A	DWS	Offset (in)	N/A		
N/A	Shared Landing?	N/A						
N/A	Gutter Ponding?	Yes	N/A	Gutte	r Slope (%)	N/A		
N/A	Gutter Lip Ht (in)	N/A	N/A	Gutte	r X Slope (%)	N/A		
N/A	Painted X Walk1?	Yes	N/A	Paint	ed X Walk2?	N/A		
	X Walk 1 Direction	To SW		X Wa	lk 2 Direction	N/A		
N/A	X Walk 1 Width (in)	111.0	N/A	X Wa	lk 2 Width (in)	N/A

X Walk 1 Slope (%)	9.2		X Wa	lk 2 Slope (%)	N/A		
	X Walk 1 X Slope (%)	3.6		X Wa	lk 2 X Slope (%)	N/A		
N/A	Ramp inside XWalk1?	Yes	N/A	Ram	inside XWalk2?	N/A		
	Road Slope (%)	N/A	N/A	Clear	Space?	N/A		
	Road X Slope (%)	N/A	N/A	Clear	Space to XWalk (in)	N/A		
N/A	Any Obstructions?	N/A	N/A	Storn	n Grate/Utility Hazard?	N/A		
	Obstruction Type			Storn	n Grate/Utility Type			
		N/A				N/A		
			Yes	Surfa	ce Condition? (G/P)	Good		
ATA

rossible Solution	
Possible Solutions:	
Remove & Replace Entire Ramp.	ı
	ı
	ı
	I
	ı
Surveyor Notes:	
N/A	
	!
PROW/ADA:	
Not Found, R304.5.1	ı
•	ı
	l
