# Access Compliance Report

## Public Rights-of-Way

### (Curb Ramps)

Intersection ID: 6933	Main Street: OAKDALE_RD	Cross Street: OLD_PLANK_RD	Location: NE
ADA ID: CE6972003068	Ramp Type: Perp	Initial Pass/Fail: Fail	Overall Compliance: No
			Severity Score: 13.75

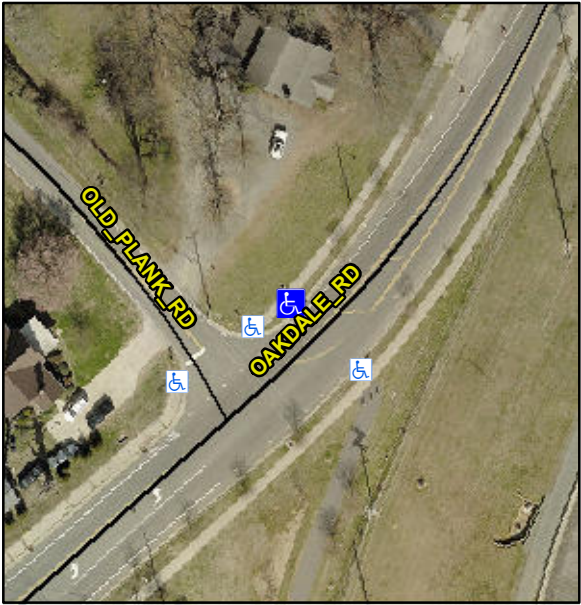
Compliance	Description	Data	Compliance	Description	Data
N/A	Ramp Length (in)	51.0	No	Ramp Slope (%)	8.5
Yes	Ramp Width (in)	83.0	No	Ramp XSlope (%)	3.0
N/A	Flare Type LT	N/A	N/A	Flare Type RT	N/A
N/A	Flare Slope LT (%)	N/A	N/A	Flare Slope RT (%)	N/A
N/A	Flare Traversable LT?	N/A	N/A	Flare Traversable RT?	N/A
N/A	Landing Length (in)	N/A	N/A	DWS Provided?	N/A
N/A	Landing Width (in)	N/A	N/A	DWS Contrast?	N/A
N/A	Landing Slope (%)	N/A	N/A	DWS Length (in)	N/A
N/A	Landing X Slope (%)	N/A	N/A	DWS Full Width?	N/A
N/A	Landing Curb? (Y/N)	N/A	N/A	DWS Offset (in)	N/A
N/A	Shared Landing?	N/A			
N/A	Gutter Ponding?	N/A	N/A	Gutter Slope (%)	N/A
N/A	Gutter Lip Ht (in)	N/A	N/A	Gutter X Slope (%)	N/A
N/A	Painted X Walk1?	No	N/A	Painted X Walk2?	N/A
	X Walk 1 Direction	To SE		X Walk 2 Direction	N/A
N/A	X Walk 1 Width (in)	N/A	N/A	X Walk 2 Width (in)	N/A
	X Walk 1 Slope (%)	0.4		X Walk 2 Slope (%)	N/A
	X Walk 1 X Slope (%)	2.1		X Walk 2 X Slope (%)	N/A

N/A	Ramp inside XWalk1?	N/A	N/A	Ramp inside XWalk2?	N/A
	Road Slope (%)	N/A	N/A	Clear Space?	N/A
	Road X Slope (%)	N/A	N/A	Clear Space to XWalk (in)	N/A
N/A	Any Obstructions?	N/A	N/A	Storm Grate/Utility Hazard?	N/A
	Obstruction Type			Storm Grate/Utility Type	
		N/A			N/A
			Yes	Surface Condition? (G/P)	Good

Possible Solutions:				
	Remove & Replace Entire Ramp.				
	Surveyor Notes:				
	N/A				
	PROW/ADA:				
	Not Found, R304.2.2, R304.5.3				
Street 1 Name	OAKDALE RD				
Stop Condition-Street 2	None				
Street 2 Name	N/A				
Stop Condition-Street 1	N/A				
	Total Cost:	\$	1850.00
