Access Compliance Report

Public Rights-of-Way

(Curb Ramps)

| Intersection ID: N/A | Main Street: E_STONEWALL_ST | Cross Street: DAVIDSON_ST | Location: W |

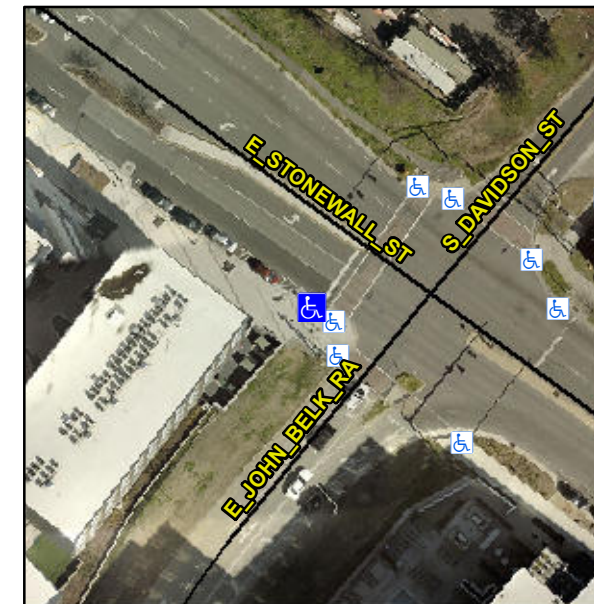
| ADA ID: CE7320D8B342 | Ramp Type: Perp | Initial Pass/Fail: Pass | Overall Compliance: No |
| Severity Score: 5.25 | | | |

R304.2.3, R305.2

| Compliance | Description | Data | Compliance | Description | Data |
|---|---|---|---|---|---|
| No | Flare Type | Curbed_WithWalkSurface | Yes | Flare Type RT | N/A |
| No | Flare Slope LT (%) | N/A | N/A | Flare Slope RT (%) | N/A |
| N/A | Landing Curb? (Y/N) | No | No | DWS Offset (in) | 2.5 |

Remove & Replace Entire Ramp.

Total Cost: \$ 1850.00
