Access Compliance Report

Public Rights-of-Way

(Curb Ramps)

Intersection ID: 5904	Main Street: COULWOOD_DR	Cross Street: MELLWOOD_DR	Location:	E
ADA ID: CE73297B3D75	Ramp Type: Directional1	Initial Pass/Fail: Pass	Overall Compliance: No	Severity Score: 2.5

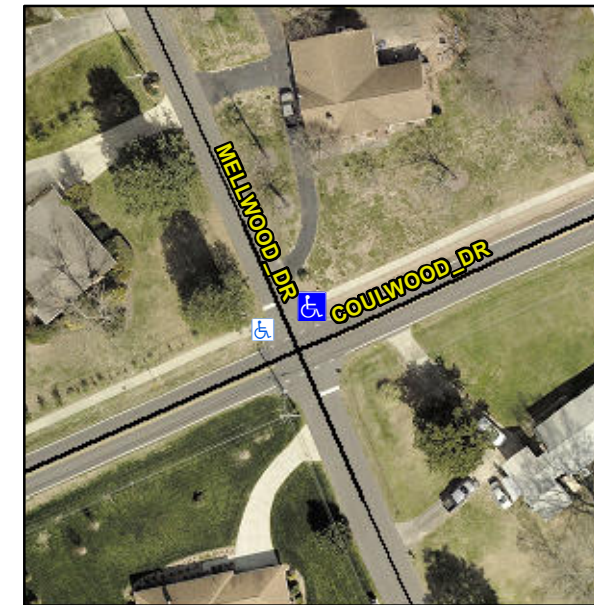
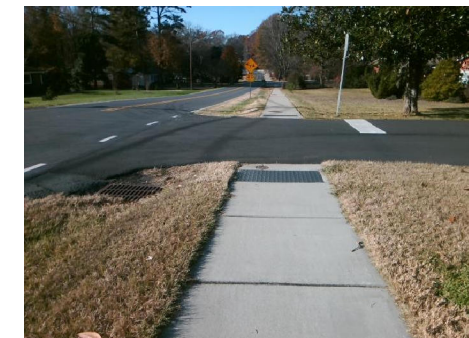
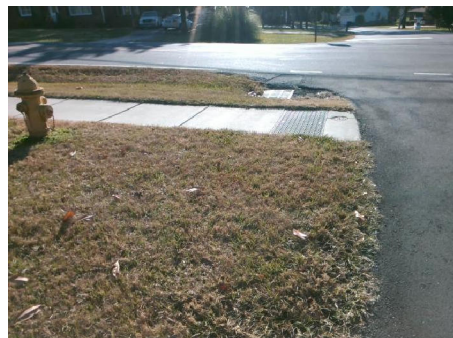
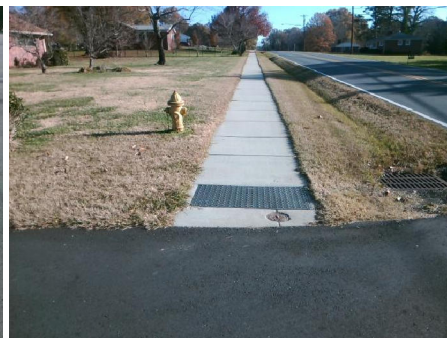
R304.2.1, R304.2.2-Perp, R304.3.2-Para, R304.5.3, R305.1.4, R305.2

Compliance	Description	Data	Compliance	Description	Data
N/A	Ramp Length (in)	72.0	Yes	Grade Break?	Yes
Yes	Ramp Width (in)	60.0	Yes	Grade Break Slope (%)	1.6
Yes	Ramp Slope (%)	1.9	No	Grade Break XSlope (%)	2.3
Yes	Ramp XSlope (%)	1.8			
N/A	Flare Type LT	N/A	N/A	Flare Type RT	N/A
N/A	Flare Slope LT (%)	N/A	N/A	Flare Slope RT (%)	N/A
N/A	Flare Traversable LT?	N/A	N/A	Flare Traversable RT?	N/A
No	Landing Length (in)	46.0	Yes	DWS Provided?	Yes
Yes	Landing Width (in)	60.0	Yes	DWS Contrast?	Yes
No	Landing Slope (%)	2.5	Yes	DWS Length (in)	24.0
No	Landing X Slope (%)	2.5	No	DWS Full Width?	No
N/A	Landing Curb? (Y/N)	No	Yes	DWS Offset LT (in)	16.5
N/A	Shared Landing?	No	No	DWS Offset RT (in)	13.0
Yes	Gutter Ponding?	No	Yes	Gutter Slope (%)	2.2
Yes	Gutter Lip Ht (in)	0.0	Yes	Gutter X Slope (%)	1.5
N/A	Painted X Walk1?	No		Road Slope (%)	1.1
	X Walk 1 Direction	To SW		Road X Slope (%)	1.1
	X Walk 1 Width (in)	N/A		Clear Space?	Yes

X Walk 1 Slope (%)	1.1	N/A	Clear Space to XWalk (in)	N/A
	X Walk 1 X Slope (%)	1.1	Yes	Storm Grate/Utility Hazard?	No
N/A	Ramp inside XWalk1?	N/A		Storm Grate/Utility Type	
Yes	Any Obstructions?	No			N/A
	Obstruction Type		Yes	Surface Condition? (G/P)	Good
			N/A	Curb Slope (%)	0.1

Remove & Replace Entire Ramp.
