Access Compliance Report

Public Rights-of-Way (Curb Ramps)

Intersection ID: 50325	Main Street: FITCHBURG_CT	Cross Street: SHARPES_CR	Location: SE
ADA ID: CE802F77D855	Ramp Type: PerpDiag	Initial Pass/Fail: Fail	Overall Compliance: No
		Severity Score: 8.75

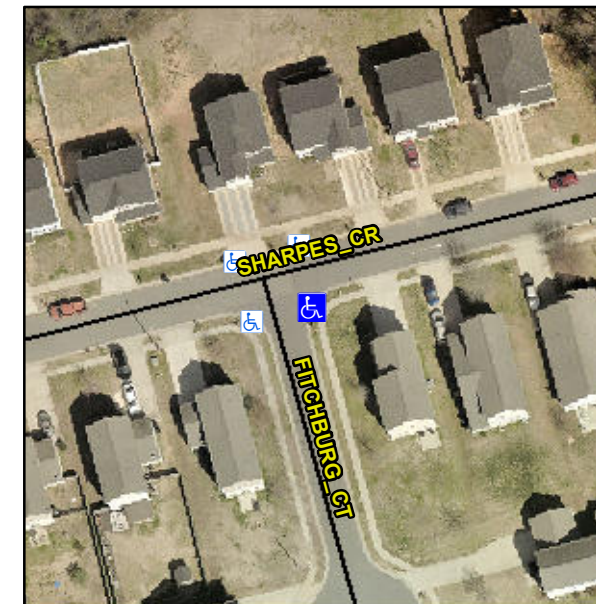
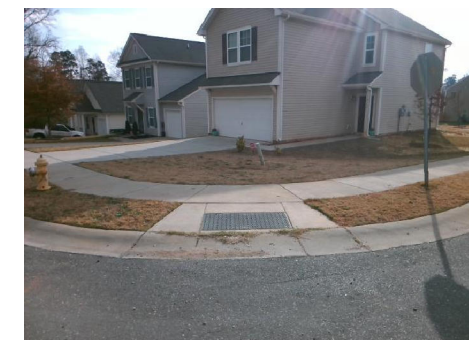
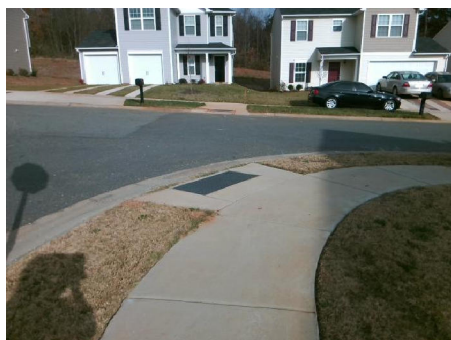
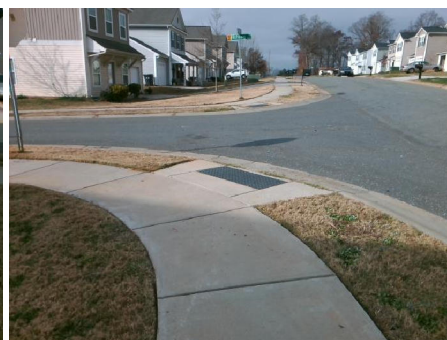
Not Found, R304.5.1

Compliance	Description	Data	Compliance	Description	Data
N/A	Ramp Length (in)	49.0	Yes	Ramp Slope (%)	5.5
No	Ramp Width (in)	47.5	Yes	Ramp XSlope (%)	1.0
N/A	Flare Type LT	N/A	N/A	Flare Type RT	N/A
N/A	Flare Slope LT (%)	N/A	N/A	Flare Slope RT (%)	N/A
N/A	Flare Traversable LT?	N/A	N/A	Flare Traversable RT?	N/A
N/A	Landing Length (in)	N/A	N/A	DWS Provided?	N/A
N/A	Landing Width (in)	N/A	N/A	DWS Contrast?	N/A
N/A	Landing Slope (%)	N/A	N/A	DWS Length (in)	N/A
N/A	Landing X Slope (%)	N/A	N/A	DWS Full Width?	N/A
N/A	Landing Curb? (Y/N)	N/A	N/A	DWS Offset (in)	N/A
N/A	Shared Landing?	N/A			
N/A	Gutter Ponding?	Yes	N/A	Gutter Slope (%)	N/A
N/A	Gutter Lip Ht (in)	N/A	N/A	Gutter X Slope (%)	N/A
N/A	Painted X Walk1?	No	N/A	Painted X Walk2?	No
	X Walk 1 Direction	To N		X Walk 2 Direction	To W
N/A	X Walk 1 Width (in)	N/A	N/A	X Walk 2 Width (in)	N/A
	X Walk 1 Slope (%)	3.1		X Walk 2 Slope (%)	6.0
	X Walk 1 X Slope (%)	3.3		X Walk 2 X Slope (%)	3.8

N/A	Ramp inside XWalk1?	N/A	N/A	Ramp inside XWalk2?	N/A
	Road Slope (%)	0.8	N/A	Clear Space?	N/A
	Road X Slope (%)	5.4	N/A	Clear Space to XWalk (in)	N/A
N/A	Any Obstructions?	N/A	N/A	Storm Grate/Utility Hazard?	N/A
	Obstruction Type			Storm Grate/Utility Type	
		N/A			N/A
		Yes		Surface Condition? (G/P)	Good

Remove & Replace Curb Ramp With Two New Directional Ramps or Equivalent.
