Access Compliance Report

Public Rights-of-Way

(Curb Ramps)

Intersection ID: 10034124	Main Street: PATRICIA_RYAN_DR	Cross Street: N/A	Location:	N
ADA ID: CE85442C5F70	Ramp Type: Perp	Initial Pass/Fail: Fail	Overall Compliance: No	Severity Score: 10
Codes/Mitigation Info/Possible Solution		Field Measurements/Component Compliance

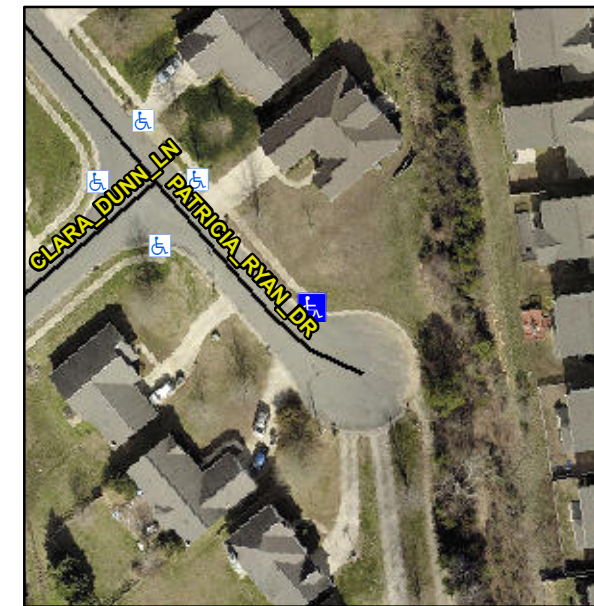
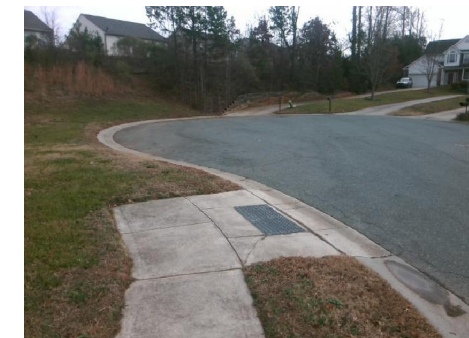
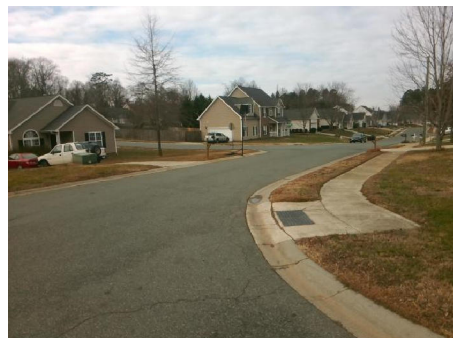
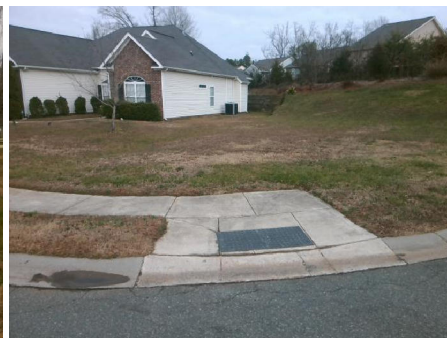
Not Found, R304.5.1, R304.5.3

Compliance	Description	Data	Compliance	Description	Data
N/A	Ramp Length (in)	46.5	Yes	Ramp Slope (%)	5.0
No	Ramp Width (in)	46.5	No	Ramp XSlope (%)	3.3
N/A	Flare Type LT	N/A	N/A	Flare Type RT	N/A
N/A	Flare Slope LT (%)	N/A	N/A	Flare Slope RT (%)	N/A
N/A	Flare Traversable LT?	N/A	N/A	Flare Traversable RT?	N/A
N/A	Landing Length (in)	N/A	N/A	DWS Provided?	N/A
N/A	Landing Width (in)	N/A	N/A	DWS Contrast?	N/A
N/A	Landing Slope (%)	N/A	N/A	DWS Length (in)	N/A
N/A	Landing X Slope (%)	N/A	N/A	DWS Full Width?	N/A
N/A	Landing Curb? (Y/N)	N/A	N/A	DWS Offset (in)	N/A
N/A	Shared Landing?	N/A			
N/A	Gutter Ponding?	N/A	N/A	Gutter Slope (%)	N/A
N/A	Gutter Lip Ht (in)	N/A	N/A	Gutter X Slope (%)	N/A
N/A	Painted X Walk1?	No	N/A	Painted X Walk2?	N/A
	X Walk 1 Direction	To W		X Walk 2 Direction	N/A
N/A	X Walk 1 Width (in)	N/A	N/A	X Walk 2 Width (in)	N/A
	X Walk 1 Slope (%)	1.3		X Walk 2 Slope (%)	N/A
	X Walk 1 X Slope (%)	3.1		X Walk 2 X Slope (%)	N/A

N/A	Ramp inside XWalk1?	N/A	N/A	Ramp inside XWalk2?	N/A
	Road Slope (%)	3.1	N/A	Clear Space?	N/A
	Road X Slope (%)	1.3	N/A	Clear Space to XWalk (in)	N/A
N/A	Any Obstructions?	N/A	N/A	Storm Grate/Utility Hazard?	N/A
	Obstruction Type			Storm Grate/Utility Type	
		N/A			N/A
			Yes	Surface Condition? (G/P)	Good

Remove & Replace Entire Ramp.
