Access Compliance Report

Public Rights-of-Way

(Curb Ramps)

Intersection ID: 31083	Main Street: BROOKINGS_DR	Cross Street: TAUTEN_CT	Location:	N
ADA ID: CE89D2AF5055	Ramp Type: PerpDiag	Initial Pass/Fail: Fail	Overall Compliance: No	Severity Score: 8.75
Codes/Mitigation Info/Possible Solution		Field Measurements/Component Compliance

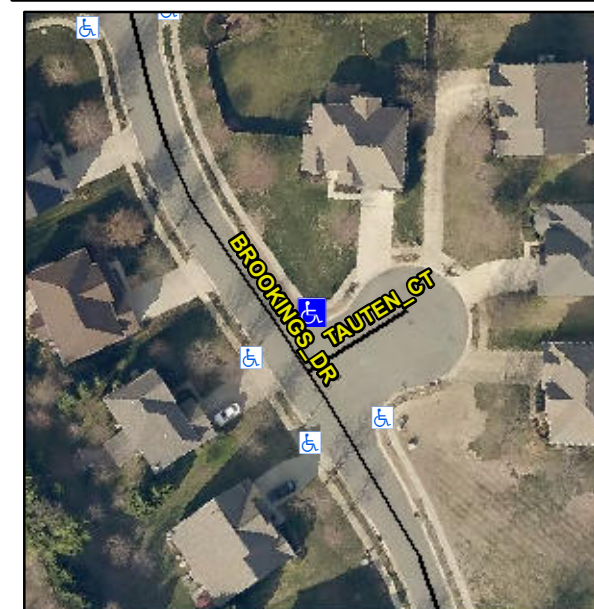
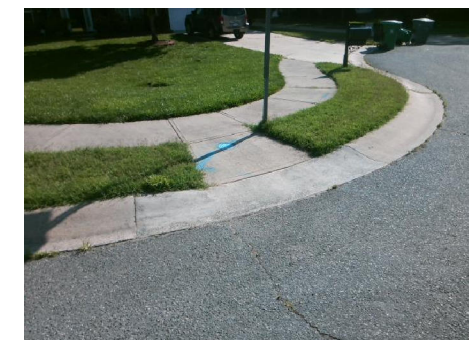
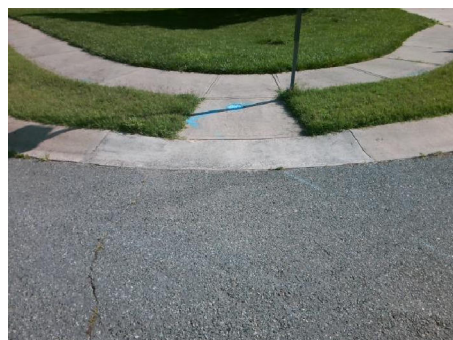
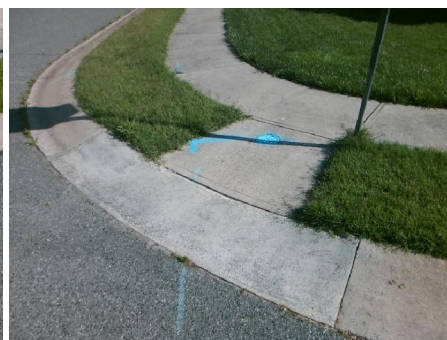
Compliance	Description	Data	Compliance	Description	Data
N/A	Ramp Length (in)	46.0	Yes	Ramp Slope (%)	7.0
No	Ramp Width (in)	44.0	Yes	Ramp XSlope (%)	0.9
N/A	Flare Type LT	N/A	N/A	Flare Type RT	N/A
N/A	Flare Slope LT (%)	N/A	N/A	Flare Slope RT (%)	N/A
N/A	Flare Traversable LT?	N/A	N/A	Flare Traversable RT?	N/A
N/A	Landing Length (in)	N/A	N/A	DWS Provided?	N/A
N/A	Landing Width (in)	N/A	N/A	DWS Contrast?	N/A
N/A	Landing Slope (%)	N/A	N/A	DWS Length (in)	N/A
N/A	Landing X Slope (%)	N/A	N/A	DWS Full Width?	N/A
N/A	Landing Curb? (Y/N)	N/A	N/A	DWS Offset (in)	N/A
N/A	Shared Landing?	N/A			
N/A	Gutter Ponding?	N/A	N/A	Gutter Slope (%)	N/A
N/A	Gutter Lip Ht (in)	N/A	N/A	Gutter X Slope (%)	N/A
N/A	Painted X Walk1?	No	N/A	Painted X Walk2?	No
	X Walk 1 Direction	To SW		X Walk 2 Direction	To SE
N/A	X Walk 1 Width (in)	N/A	N/A	X Walk 2 Width (in)	N/A
	X Walk 1 Slope (%)	1.4		X Walk 2 Slope (%)	1.9
	X Walk 1 X Slope (%)	2.1		X Walk 2 X Slope (%)	0.2

N/A	Ramp inside XWalk1?	N/A	N/A	Ramp inside XWalk2?	N/A
	Road Slope (%)	0.3	N/A	Clear Space?	N/A
	Road X Slope (%)	0.4	N/A	Clear Space to XWalk (in)	N/A
N/A	Any Obstructions?	N/A	N/A	Storm Grate/Utility Hazard?	N/A
	Obstruction Type			Storm Grate/Utility Type	
		N/A			N/A
			Yes	Surface Condition? (G/P)	Good

Remove & Replace Curb Ramp With Two New Directional Ramps or Equivalent.

R304.5.1
