# Access Compliance Report

## Public Rights-of-Way

### (Curb Ramps)

Intersection ID: 10855	Main Street: WHITING_AV	Cross Street: HOLT_ST	Location:	N
ADA ID: CE9B3A979A05	Ramp Type: BlendTrans1	Initial Pass/Fail: Fail	Overall Compliance: No	Severity Score: 10
Codes/Mitigation Info/Possible Solution		Field Measurements/Component Compliance

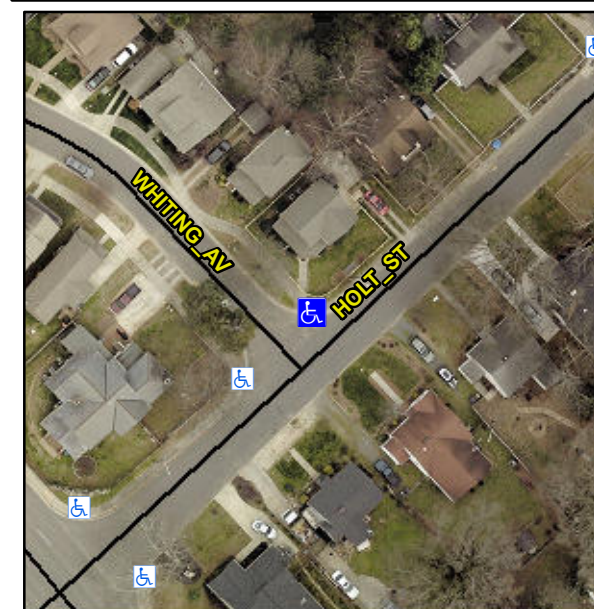
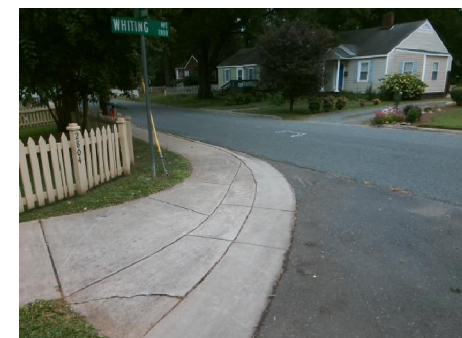
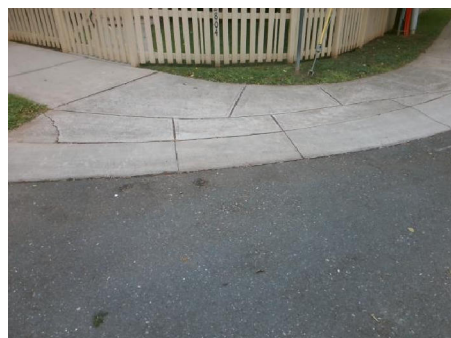
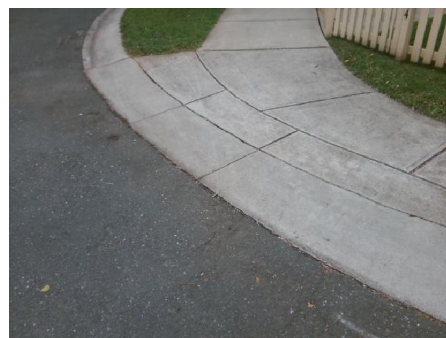
**Not Found, R304.5.1, R304.5.3**

Compliance	Description	Data	Compliance	Description	Data
N/A	Ramp Length (in)	18.0	Yes	BlendTrans Slope (%)	3.3
No	Ramp Width (in)	46.0	No	BlendTrans XSlope (%)	2.1
N/A	Flare Type LT	N/A	N/A	Flare Type RT	N/A
N/A	Flare Slope LT (%)	N/A	N/A	Flare Slope RT (%)	N/A
N/A	Flare Traversable LT?	N/A	N/A	Flare Traversable RT?	N/A
N/A	Landing Length (in)	N/A	N/A	DWS Provided?	N/A
N/A	Landing Width (in)	N/A	N/A	DWS Contrast?	N/A
N/A	Landing Slope (%)	N/A	N/A	DWS Length (in)	N/A
N/A	Landing X Slope (%)	N/A	N/A	DWS Full Width?	N/A
N/A	Landing Curb? (Y/N)	N/A	N/A	DWS Offset (in)	N/A
N/A	Shared Landing?	N/A			
N/A	Gutter Ponding?	N/A	N/A	Gutter Slope (%)	N/A
N/A	Gutter Lip Ht (in)	N/A	N/A	Gutter X Slope (%)	N/A
N/A	Painted X Walk1?	No	N/A	Painted X Walk2?	N/A
	X Walk 1 Direction	To SW		X Walk 2 Direction	N/A
	X Walk 1 Width (in)	N/A		X Walk 2 Width (in)	N/A
	X Walk 1 Slope (%)	3.5		X Walk 2 Slope (%)	N/A
	X Walk 1 X Slope (%)	0.1		X Walk 2 X Slope (%)	N/A

N/A	Ramp inside XWalk1?	N/A	N/A	Ramp inside XWalk2?	N/A
	Road Slope (%)	0.1		Clear Space?	N/A
	Road X Slope (%)	3.5	N/A	Clear Space to XWalk (in)	N/A
N/A	Any Obstructions?	N/A	N/A	Storm Grate/Utility Hazard?	N/A
	Obstruction Type			Storm Grate/Utility Type	
		N/A			N/A
			Yes	Surface Condition? (G/P)	Good
			No	Curb Slope (%)	7.3

**Remove & Replace Curb Ramp With Two New Directional Ramps or Equivalent.**
