# Access Compliance Report

## Public Rights-of-Way

### (Curb Ramps)

Intersection ID: 3160	Main Street: BASKERVILLE_AV	Cross Street: CHISWELL_CT	Location: SW
ADA ID: CEB1E1BCC781	Ramp Type: Perp	Initial Pass/Fail: Fail	Overall Compliance: No
Severity Score: 1.25			
Codes/Mitigation Info/Possible Solution		Field Measurements/Component Compliance

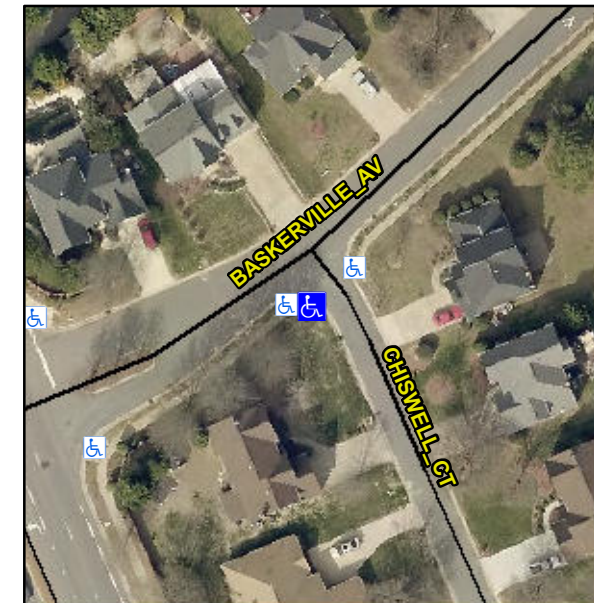
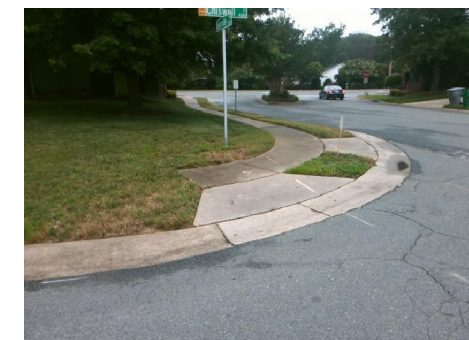
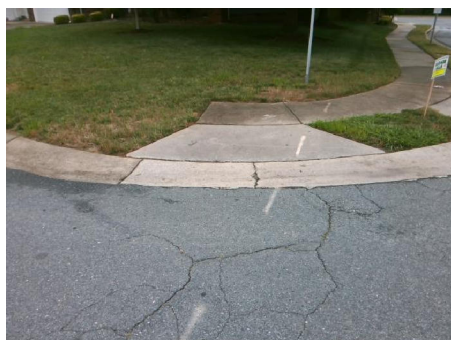
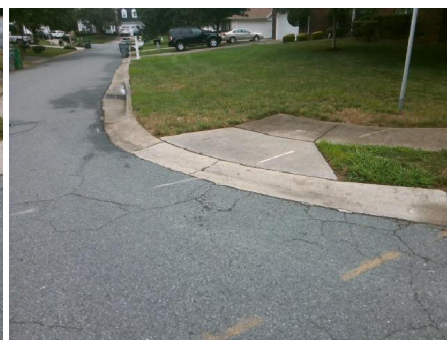
**Not Found, R304.5.3**

Compliance	Description	Data	Compliance	Description	Data
N/A	Ramp Length (in)	46.0	Yes	Ramp Slope (%)	6.4
Yes	Ramp Width (in)	60.0	No	Ramp XSlope (%)	2.5
N/A	Flare Type LT	N/A	N/A	Flare Type RT	N/A
N/A	Flare Slope LT (%)	N/A	N/A	Flare Slope RT (%)	N/A
N/A	Flare Traversable LT?	N/A	N/A	Flare Traversable RT?	N/A
N/A	Landing Length (in)	N/A	N/A	DWS Provided?	N/A
N/A	Landing Width (in)	N/A	N/A	DWS Contrast?	N/A
N/A	Landing Slope (%)	N/A	N/A	DWS Length (in)	N/A
N/A	Landing X Slope (%)	N/A	N/A	DWS Full Width?	N/A
N/A	Landing Curb? (Y/N)	N/A	N/A	DWS Offset (in)	N/A
N/A	Shared Landing?	N/A			
N/A	Gutter Ponding?	N/A	N/A	Gutter Slope (%)	N/A
N/A	Gutter Lip Ht (in)	N/A	N/A	Gutter X Slope (%)	N/A
N/A	Painted X Walk1?	No	N/A	Painted X Walk2?	N/A
	X Walk 1 Direction	To E		X Walk 2 Direction	N/A
N/A	X Walk 1 Width (in)	N/A	N/A	X Walk 2 Width (in)	N/A
	X Walk 1 Slope (%)	4.1		X Walk 2 Slope (%)	N/A
	X Walk 1 X Slope (%)	3.3		X Walk 2 X Slope (%)	N/A

N/A	Ramp inside XWalk1?	N/A	N/A	Ramp inside XWalk2?	N/A
	Road Slope (%)	N/A	N/A	Clear Space?	N/A
	Road X Slope (%)	N/A	N/A	Clear Space to XWalk (in)	N/A
N/A	Any Obstructions?	N/A	N/A	Storm Grate/Utility Hazard?	N/A
	Obstruction Type			Storm Grate/Utility Type	
		N/A			N/A
		Yes		Surface Condition? (G/P)	Good

**Remove & Replace Entire Ramp.**

Total Cost: \$ 1850.00
