Access Compliance Report

Public Rights-of-Way

(Curb Ramps)

Intersection ID: 10038266	Main Street: SMITHFIELD_CHURCH_RD	Cross Street: N/A	Location: S
ADA ID: CEB39FBD0375	Ramp Type: Perp	Initial Pass/Fail: Fail	Overall Compliance: No
Codes/Mitigation Info/Possible Solution		Field Measurements/Component Compliance	
Severity Score: 25

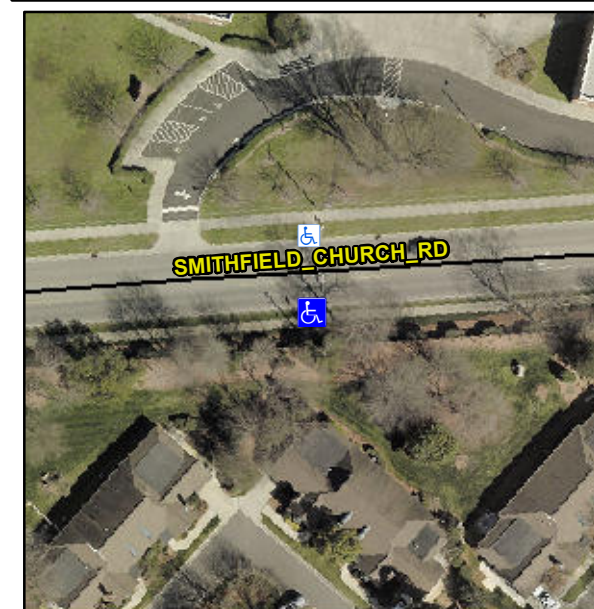
Not Found, R304.2.2

Compliance	Description	Data	Compliance	Description	Data
N/A	Ramp Length (in)	47.0	No	Ramp Slope (%)	14.9
Yes	Ramp Width (in)	89.0	Yes	Ramp XSlope (%)	0.5
N/A	Flare Type LT	N/A	N/A	Flare Type RT	N/A
N/A	Flare Slope LT (%)	N/A	N/A	Flare Slope RT (%)	N/A
N/A	Flare Traversable LT?	N/A	N/A	Flare Traversable RT?	N/A
N/A	Landing Length (in)	N/A	N/A	DWS Provided?	N/A
N/A	Landing Width (in)	N/A	N/A	DWS Contrast?	N/A
N/A	Landing Slope (%)	N/A	N/A	DWS Length (in)	N/A
N/A	Landing X Slope (%)	N/A	N/A	DWS Full Width?	N/A
N/A	Landing Curb? (Y/N)	N/A	N/A	DWS Offset (in)	N/A
N/A	Shared Landing?	N/A			
N/A	Gutter Ponding?	N/A	N/A	Gutter Slope (%)	N/A
N/A	Gutter Lip Ht (in)	N/A	N/A	Gutter X Slope (%)	N/A
N/A	Painted X Walk1?	Yes	N/A	Painted X Walk2?	N/A
	X Walk 1 Direction	To N		X Walk 2 Direction	N/A
N/A	X Walk 1 Width (in)	110.0	N/A	X Walk 2 Width (in)	N/A
	X Walk 1 Slope (%)	4.2		X Walk 2 Slope (%)	N/A
	X Walk 1 X Slope (%)	0.8		X Walk 2 X Slope (%)	N/A

N/A	Ramp inside XWalk1?	Yes	N/A	Ramp inside XWalk2?	N/A
	Road Slope (%)	N/A	N/A	Clear Space?	N/A
	Road X Slope (%)	N/A	N/A	Clear Space to XWalk (in)	N/A
N/A	Any Obstructions?	N/A	N/A	Storm Grate/Utility Hazard?	N/A
	Obstruction Type			Storm Grate/Utility Type	
		N/A			N/A
			Yes	Surface Condition? (G/P)	Good

Possible Solutions:

Remove & Replace Entire Ramp.

Total Cost: \$ 1850.00
