Access Compliance Report

Public Rights-of-Way

(Curb Ramps)

Intersection ID: 16298	Main Street: W_TYVOLA_RD	Cross Street: YORKMONT_RD	Location: SE
ADA ID: CEB5DFD57C96	Ramp Type: Perp	Initial Pass/Fail: Fail	Overall Compliance: No
Severity Score: 12.5			
Codes/Mitigation Info/Possible Solution		Field Measurements/Component Compliance

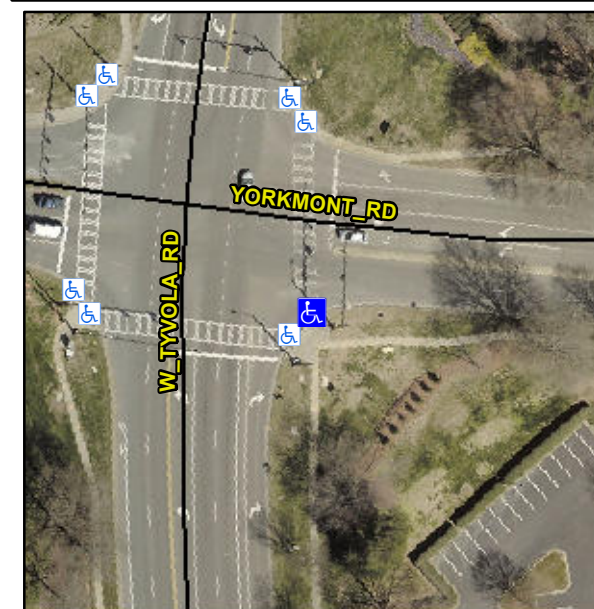
Not Found, R304.5.3

Compliance	Description	Data	Compliance	Description	Data
N/A	Ramp Length (in)	92.0	Yes	Ramp Slope (%)	6.8
Yes	Ramp Width (in)	48.0	No	Ramp XSlope (%)	6.9
N/A	Flare Type LT	N/A	N/A	Flare Type RT	N/A
N/A	Flare Slope LT (%)	N/A	N/A	Flare Slope RT (%)	N/A
N/A	Flare Traversable LT?	N/A	N/A	Flare Traversable RT?	N/A
N/A	Landing Length (in)	N/A	N/A	DWS Provided?	N/A
N/A	Landing Width (in)	N/A	N/A	DWS Contrast?	N/A
N/A	Landing Slope (%)	N/A	N/A	DWS Length (in)	N/A
N/A	Landing X Slope (%)	N/A	N/A	DWS Full Width?	N/A
N/A	Landing Curb? (Y/N)	N/A	N/A	DWS Offset (in)	N/A
N/A	Shared Landing?	N/A			
N/A	Gutter Ponding?	N/A	N/A	Gutter Slope (%)	N/A
N/A	Gutter Lip Ht (in)	N/A	N/A	Gutter X Slope (%)	N/A
N/A	Painted X Walk1?	Yes	N/A	Painted X Walk2?	N/A
	X Walk 1 Direction	To N		X Walk 2 Direction	N/A
N/A	X Walk 1 Width (in)	121.0	N/A	X Walk 2 Width (in)	N/A
	X Walk 1 Slope (%)	2.8		X Walk 2 Slope (%)	N/A
	X Walk 1 X Slope (%)	5.0		X Walk 2 X Slope (%)	N/A

N/A	Ramp inside XWalk1?	Yes	N/A	Ramp inside XWalk2?	N/A
	Road Slope (%)	N/A	N/A	Clear Space?	N/A
	Road X Slope (%)	N/A	N/A	Clear Space to XWalk (in)	N/A
N/A	Any Obstructions?	N/A	N/A	Storm Grate/Utility Hazard?	N/A
	Obstruction Type			Storm Grate/Utility Type	
		N/A			N/A
		Yes		Surface Condition? (G/P)	Good

Remove & Replace Entire Ramp.

Total Cost: \$ 1850.00
