Access Compliance Report

Public Rights-of-Way

(Curb Ramps)

Intersection ID: 21272	Main Street: CROOKED_OAK_LN	Cross Street: EAST_BARDEN_RD	Location: NW
ADA ID: CEB6FA3F4D9B	Ramp Type: Directional1	Initial Pass/Fail: Fail	Overall Compliance: No
		Severity Score: 1.25

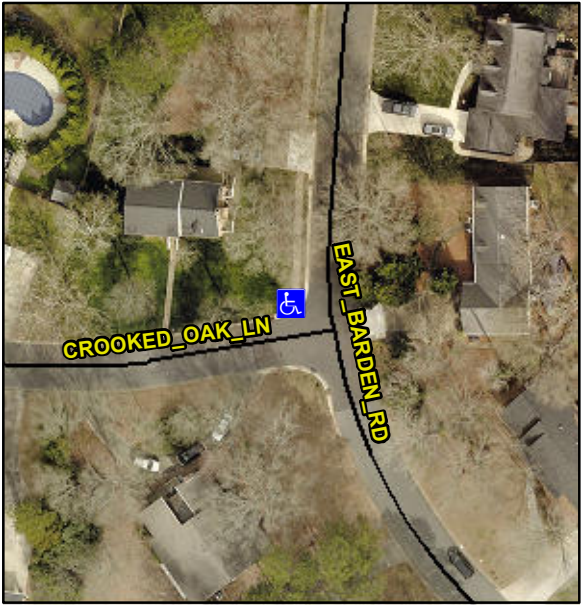
Possible Solutions:		Compliance	Description	Data	
	Remove & Replace Entire Ramp.		N/A	Ramp Length (in)	38.0	N/A
			Yes	Ramp Width (in)	48.0	N/A
			Yes	Ramp Slope (%)	3.4	N/A
			No	Ramp XSlope (%)	4.2	N/A
			N/A	Flare Type LT	N/A	N/A
			N/A	Flare Slope LT (%)	N/A	N/A
			N/A	Flare Traversable LT?	N/A	N/A
			N/A	Landing Length (in)	0.0	N/A
			N/A	Landing Width (in)	0.0	N/A
			N/A	Landing Slope (%)	0.0	N/A
			N/A	Landing X Slope (%)	0.0	N/A
			N/A	Landing Curb? (Y/N)	N/A	N/A
			N/A	Shared Landing?	N/A	N/A
			N/A	Gutter Ponding?	0.0	N/A
			N/A	Gutter Lip Ht (in)	0.0	N/A
			N/A	Painted X Walk1?	No	N/A
				X Walk 1 Direction	To S	N/A
				X Walk 1 Width (in)	N/A	N/A
				X Walk 1 Slope (%)	8.1	N/A
				X Walk 1 X Slope (%)	4.0	N/A
<p>Surveyor Notes:</p> <p>N/A</p>			N/A	Ramp inside XWalk1?	N/A	N/A
			N/A	Any Obstructions?	N/A	N/A
<p>PROW/ADA:</p> <p>R304.5.3</p>				Obstruction Type

Yes	Surface Condition? (G/P)	Good	Good
			N/A	Curb Slope (%)	2.2	2.2
Street 1 Name	CROOKED OAK LN					
Stop Condition-Street 1	StopSign					
Street 2 Name	N/A					
Stop Condition-Street 2	N/A					
Total Cost:	\$	1600.00
