Access Compliance Report

Public Rights-of-Way

(Curb Ramps)

Intersection ID: 18818	Main Street: BEAM_RD	Cross Street: SHOPTON_RD	Location: NE
ADA ID: CEBE289F7E36	Ramp Type: Perp	Initial Pass/Fail: Fail	Overall Compliance: No
			Severity Score: 13.75

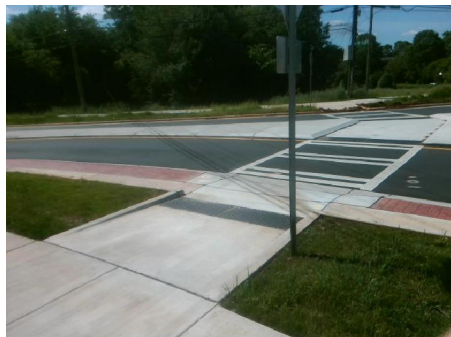
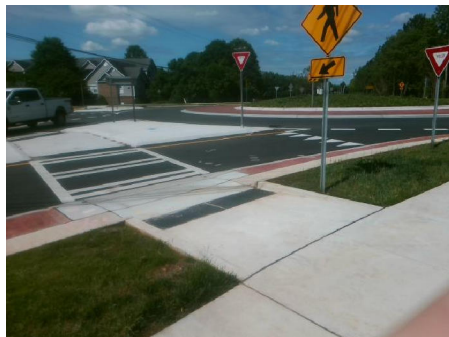
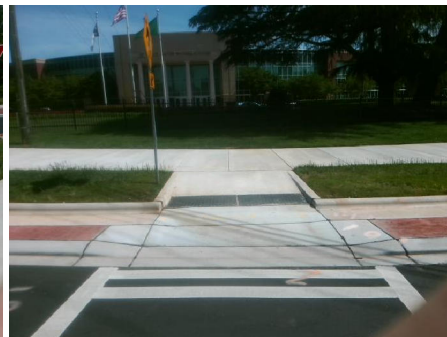
Not Found, R304.2.2, R304.5.3

Compliance	Description	Data	Compliance	Description	Data
N/A	Ramp Length (in)	153.0	No	Ramp Slope (%)	8.7
Yes	Ramp Width (in)	97.0	No	Ramp XSlope (%)	3.3
N/A	Flare Type LT	N/A	N/A	Flare Type RT	N/A
N/A	Flare Slope LT (%)	N/A	N/A	Flare Slope RT (%)	N/A
N/A	Flare Traversable LT?	N/A	N/A	Flare Traversable RT?	N/A
N/A	Landing Length (in)	N/A	N/A	DWS Provided?	N/A
N/A	Landing Width (in)	N/A	N/A	DWS Contrast?	N/A
N/A	Landing Slope (%)	N/A	N/A	DWS Length (in)	N/A
N/A	Landing X Slope (%)	N/A	N/A	DWS Full Width?	N/A
N/A	Landing Curb? (Y/N)	N/A	N/A	DWS Offset (in)	N/A
N/A	Shared Landing?	N/A			
N/A	Gutter Ponding?	N/A	N/A	Gutter Slope (%)	N/A
N/A	Gutter Lip Ht (in)	N/A	N/A	Gutter X Slope (%)	N/A
N/A	Painted X Walk1?	Yes	N/A	Painted X Walk2?	N/A
	X Walk 1 Direction	To S		X Walk 2 Direction	N/A
N/A	X Walk 1 Width (in)	112.0	N/A	X Walk 2 Width (in)	N/A
	X Walk 1 Slope (%)	4.1		X Walk 2 Slope (%)	N/A
	X Walk 1 X Slope (%)	3.1		X Walk 2 X Slope (%)	N/A

N/A	Ramp inside XWalk1?	Yes	N/A	Ramp inside XWalk2?	N/A
	Road Slope (%)	N/A	N/A	Clear Space?	N/A
	Road X Slope (%)	N/A	N/A	Clear Space to XWalk (in)	N/A
N/A	Any Obstructions?	N/A	N/A	Storm Grate/Utility Hazard?	N/A
	Obstruction Type			Storm Grate/Utility Type	
		N/A			N/A
			Yes	Surface Condition? (G/P)	Good

Remove & Replace Entire Ramp.

Total Cost: \$ 1850.00
