Access Compliance Report

Public Rights-of-Way (Curb Ramps)

Intersection ID: 29134	Main Street: BALSAM_TREE_DR	Cross Street: CREEK_BREEZE_RD	Location: SE
ADA ID: CEC11C9B3E6E	Ramp Type: BlendTrans1	Initial Pass/Fail: Fail	Overall Compliance: No
		Severity Score: 25

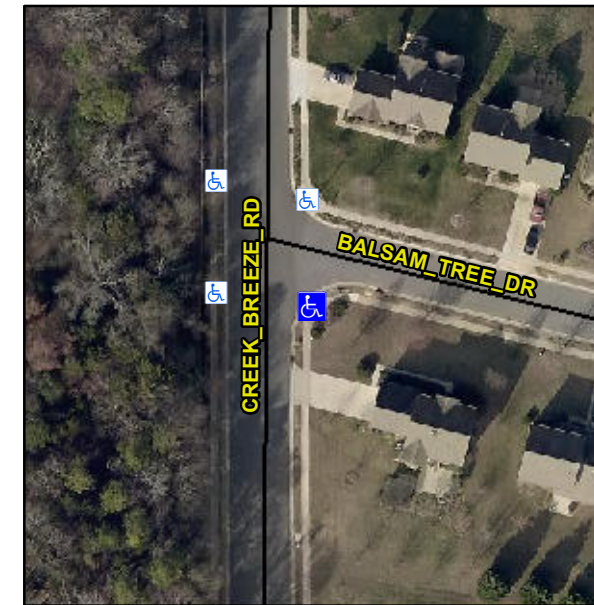
Not Found, R304.5.3

Compliance	Description	Data	Compliance	Description	Data
N/A	Ramp Length (in)	42.0	Yes	BlendTrans Slope (%)	2.7
Yes	Ramp Width (in)	64.0	No	BlendTrans XSlope (%)	7.6
N/A	Flare Type LT	N/A	N/A	Flare Type RT	N/A
N/A	Flare Slope LT (%)	N/A	N/A	Flare Slope RT (%)	N/A
N/A	Flare Traversable LT?	N/A	N/A	Flare Traversable RT?	N/A
N/A	Landing Length (in)	N/A	N/A	DWS Provided?	N/A
N/A	Landing Width (in)	N/A	N/A	DWS Contrast?	N/A
N/A	Landing Slope (%)	N/A	N/A	DWS Length (in)	N/A
N/A	Landing X Slope (%)	N/A	N/A	DWS Full Width?	N/A
N/A	Landing Curb? (Y/N)	N/A	N/A	DWS Offset (in)	N/A
N/A	Shared Landing?	N/A			
N/A	Gutter Ponding?	N/A	N/A	Gutter Slope (%)	N/A
N/A	Gutter Lip Ht (in)	N/A	N/A	Gutter X Slope (%)	N/A
N/A	Painted X Walk1?	No	N/A	Painted X Walk2?	No
	X Walk 1 Direction	To N		X Walk 2 Direction	To W
	X Walk 1 Width (in)	N/A		X Walk 2 Width (in)	N/A
	X Walk 1 Slope (%)	5.9		X Walk 2 Slope (%)	4.5
	X Walk 1 X Slope (%)	1.5		X Walk 2 X Slope (%)	7.8

N/A	Ramp inside XWalk1?	N/A	N/A	Ramp inside XWalk2?	N/A
	Road Slope (%)	5.5		Clear Space?	N/A
	Road X Slope (%)	4.0	N/A	Clear Space to XWalk (in)	N/A
N/A	Any Obstructions?	N/A	N/A	Storm Grate/Utility Hazard?	N/A
	Obstruction Type			Storm Grate/Utility Type	
		N/A			N/A
			Yes	Surface Condition? (G/P)	Good
			No	Curb Slope (%)	7.3

Remove & Replace Curb Ramp With Two New Directional Ramps or Equivalent.
