Access Compliance Report

Public Rights-of-Way

(Curb Ramps)

Intersection ID: 19258	Main Street: MARION_DIEHL_PARK_DR	Cross Street: TYVOLA_RD	Location:	NE
ADA ID: CEC75D4DBC72	Ramp Type: Directional2	Initial Pass/Fail: Fail	Overall Compliance: No	Severity Score: 42.5
Codes/Mitigation Info/Possible Solution		Field Measurements/Component Compliance

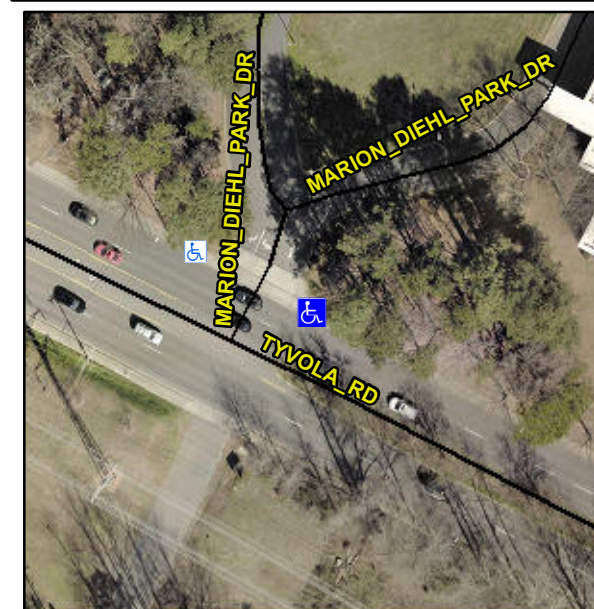
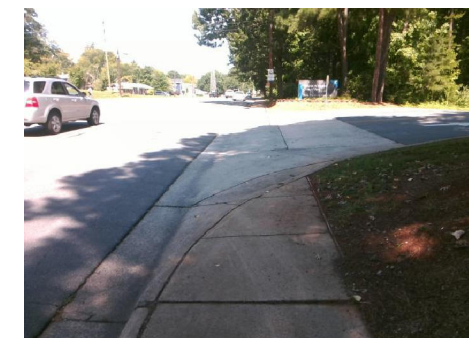
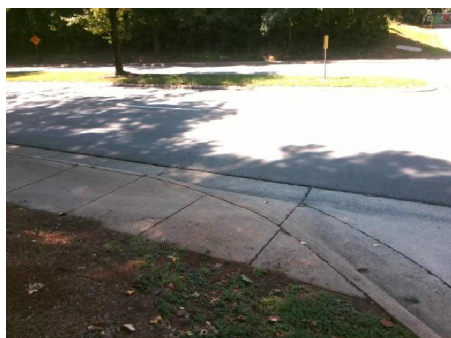
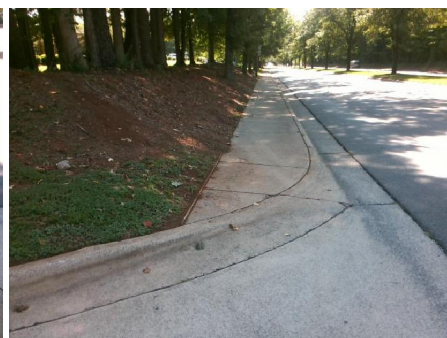
Compliance	Description	Data	Compliance	Description	Data
N/A	Ramp Length (in)	52.5	N/A	Grade Break?	N/A
No	Ramp Width (in)	35.0	N/A	Grade Break Slope (%)	0.0
Yes	Ramp Slope (%)	6.4	N/A	Grade Break XSlope (%)	0.0
No	Ramp XSlope (%)	7.7			
N/A	Flare Type LT	N/A	N/A	Flare Type RT	N/A
N/A	Flare Slope LT (%)	N/A	N/A	Flare Slope RT (%)	0.0
N/A	Flare Traversable LT?	N/A	N/A	Flare Traversable RT?	N/A
N/A	Landing Length (in)	0.0	N/A	DWS Provided?	N/A
N/A	Landing Width (in)	0.0	N/A	DWS Contrast?	N/A
N/A	Landing Slope (%)	0.0	N/A	DWS Length (in)	N/A
N/A	Landing X Slope (%)	0.0	N/A	DWS Full Width?	N/A
N/A	Landing Curb? (Y/N)	N/A	N/A	DWS Offset LT (in)	N/A
N/A	Shared Landing?	N/A	N/A	DWS Offset RT (in)	N/A
N/A	Gutter Ponding?	0.0	N/A	Gutter Slope (%)	N/A
N/A	Gutter Lip Ht (in)	0.0	N/A	Gutter X Slope (%)	N/A
N/A	Painted X Walk1?	No		Road Slope (%)	2.5
	X Walk 1 Direction	To W		Road X Slope (%)	7.4
	X Walk 1 Width (in)	N/A		Clear Space?	N/A

X Walk 1 Slope (%)	2.5	N/A	Clear Space to XWalk (in)	N/A
	X Walk 1 X Slope (%)	7.4	N/A	Storm Grate/Utility Hazard?	N/A
N/A	Ramp inside XWalk1?	N/A		Storm Grate/Utility Type	
N/A	Any Obstructions?	N/A			N/A
	Obstruction Type		Yes	Surface Condition? (G/P)	Good
			N/A	Curb Slope (%)	9.2

Remove & Replace Entire Ramp.

R304.5.1, R304.5.3
