Access Compliance Report

Public Rights-of-Way

(Curb Ramps)

Intersection ID: 7537	Main Street: BIRCHHOLLOW_DR	Cross Street: WILD_NURSERY_CT	Location:	E
ADA ID: CED3B5D7932E	Ramp Type: PerpDiag	Initial Pass/Fail: Fail	Overall Compliance: No	Severity Score: 21.25
Codes/Mitigation Info/Possible Solution		Field Measurements/Component Compliance

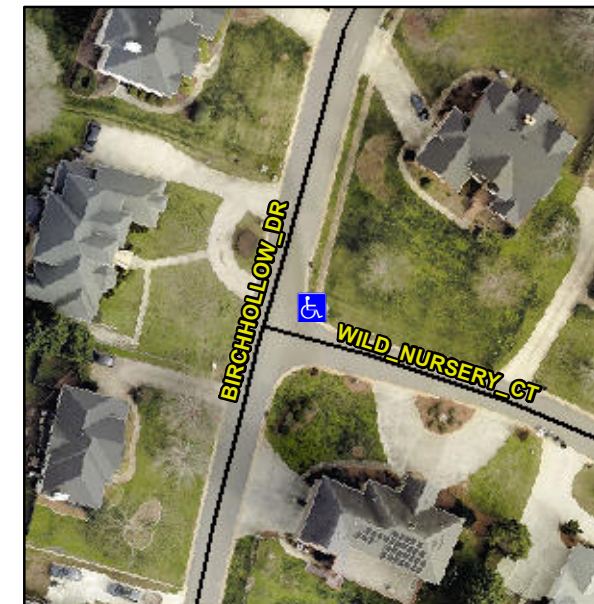
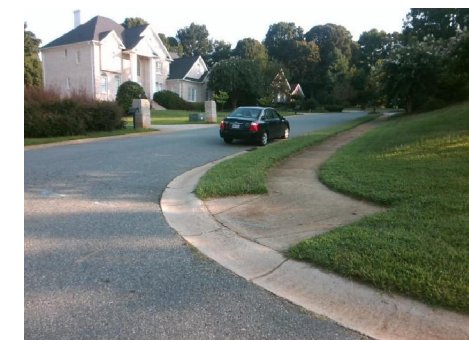
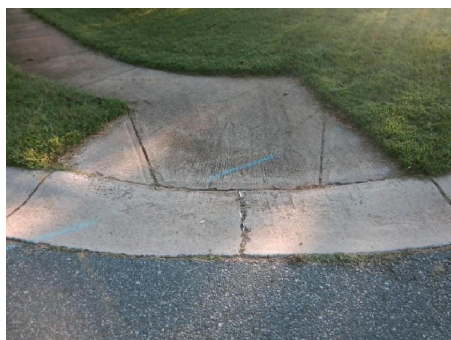
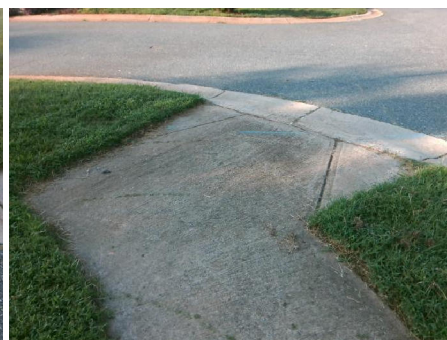
Not Found, R304.5.1, R304.2.2

Compliance	Description	Data	Compliance	Description	Data
N/A	Ramp Length (in)	46.0	No	Ramp Slope (%)	8.7
No	Ramp Width (in)	43.0	Yes	Ramp XSlope (%)	1.4
N/A	Flare Type LT	N/A	N/A	Flare Type RT	N/A
N/A	Flare Slope LT (%)	N/A	N/A	Flare Slope RT (%)	N/A
N/A	Flare Traversable LT?	N/A	N/A	Flare Traversable RT?	N/A
N/A	Landing Length (in)	N/A	N/A	DWS Provided?	N/A
N/A	Landing Width (in)	N/A	N/A	DWS Contrast?	N/A
N/A	Landing Slope (%)	N/A	N/A	DWS Length (in)	N/A
N/A	Landing X Slope (%)	N/A	N/A	DWS Full Width?	N/A
N/A	Landing Curb? (Y/N)	N/A	N/A	DWS Offset (in)	N/A
N/A	Shared Landing?	N/A			
N/A	Gutter Ponding?	N/A	N/A	Gutter Slope (%)	N/A
N/A	Gutter Lip Ht (in)	0.5	N/A	Gutter X Slope (%)	N/A
N/A	Painted X Walk1?	No	N/A	Painted X Walk2?	No
	X Walk 1 Direction	To W		X Walk 2 Direction	To S
N/A	X Walk 1 Width (in)	N/A	N/A	X Walk 2 Width (in)	N/A
	X Walk 1 Slope (%)	N/A		X Walk 2 Slope (%)	N/A
	X Walk 1 X Slope (%)	N/A		X Walk 2 X Slope (%)	N/A

N/A	Ramp inside XWalk1?	N/A	N/A	Ramp inside XWalk2?	N/A
	Road Slope (%)	2.3	N/A	Clear Space?	N/A
	Road X Slope (%)	6.6	N/A	Clear Space to XWalk (in)	N/A
N/A	Any Obstructions?	N/A	N/A	Storm Grate/Utility Hazard?	N/A
	Obstruction Type			Storm Grate/Utility Type	
		N/A			N/A
		Yes		Surface Condition? (G/P)	Good

Remove & Replace Curb Ramp With Two New Directional Ramps or Equivalent.

Total Cost: \$ 3200.00
