Access Compliance Report

Public Rights-of-Way

(Curb Ramps)

Intersection ID: N/A	Main Street: MARKLAND_DR	Cross Street: ELKMONT_PL	Location: NE
ADA ID: CEDC2CC0CEAC	Ramp Type: PerpDiag	Initial Pass/Fail: Fail	Overall Compliance: No
Severity Score: 8.75			
Codes/Mitigation Info/Possible Solution		Field Measurements/Component Compliance

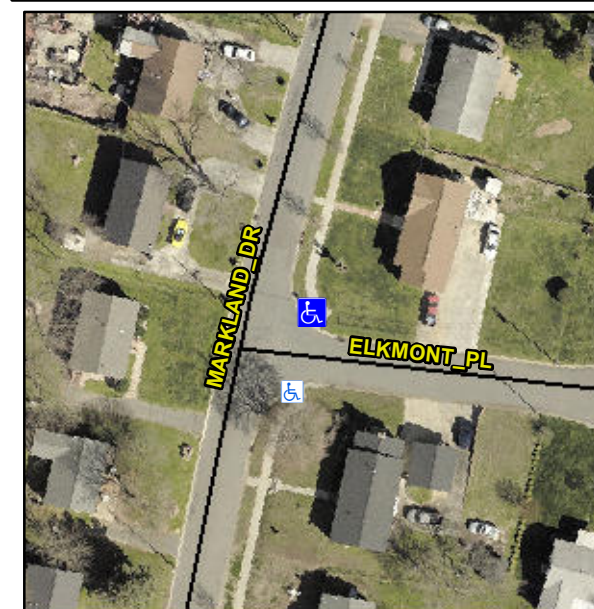
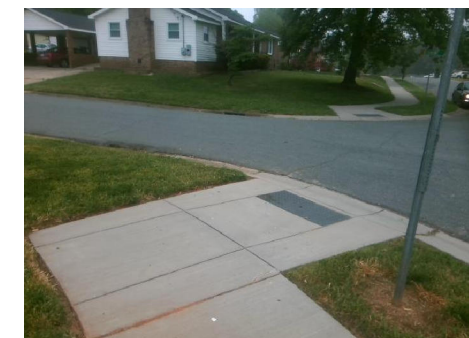
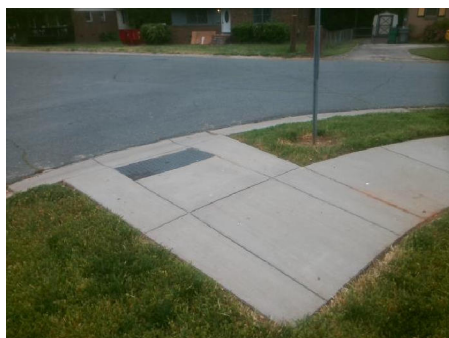
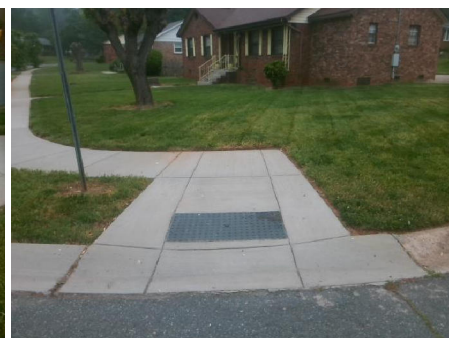
Not Found, R304.5.1

Compliance	Description	Data	Compliance	Description	Data
N/A	Ramp Length (in)	73.0	Yes	Ramp Slope (%)	7.0
No	Ramp Width (in)	45.0	Yes	Ramp XSlope (%)	0.7
N/A	Flare Type LT	N/A	N/A	Flare Type RT	N/A
N/A	Flare Slope LT (%)	N/A	N/A	Flare Slope RT (%)	N/A
N/A	Flare Traversable LT?	N/A	N/A	Flare Traversable RT?	N/A
N/A	Landing Length (in)	N/A	N/A	DWS Provided?	N/A
N/A	Landing Width (in)	N/A	N/A	DWS Contrast?	N/A
N/A	Landing Slope (%)	N/A	N/A	DWS Length (in)	N/A
N/A	Landing X Slope (%)	N/A	N/A	DWS Full Width?	N/A
N/A	Landing Curb? (Y/N)	N/A	N/A	DWS Offset (in)	N/A
N/A	Shared Landing?	N/A			
N/A	Gutter Ponding?	N/A	N/A	Gutter Slope (%)	N/A
N/A	Gutter Lip Ht (in)	N/A	N/A	Gutter X Slope (%)	N/A
N/A	Painted X Walk1?	No	N/A	Painted X Walk2?	No
	X Walk 1 Direction	To W		X Walk 2 Direction	To S
N/A	X Walk 1 Width (in)	N/A	N/A	X Walk 2 Width (in)	N/A
	X Walk 1 Slope (%)	0.6		X Walk 2 Slope (%)	2.9
	X Walk 1 X Slope (%)	2.5		X Walk 2 X Slope (%)	0.9

N/A	Ramp inside XWalk1?	N/A	N/A	Ramp inside XWalk2?	N/A
	Road Slope (%)	0.2	N/A	Clear Space?	N/A
	Road X Slope (%)	2.3	N/A	Clear Space to XWalk (in)	N/A
N/A	Any Obstructions?	N/A	N/A	Storm Grate/Utility Hazard?	N/A
	Obstruction Type			Storm Grate/Utility Type	
		N/A			N/A
		Yes		Surface Condition? (G/P)	Good

Remove & Replace Curb Ramp With Two New Directional Ramps or Equivalent.

Total Cost: \$ 3200.00
