Access Compliance Report

Public Rights-of-Way

(Curb Ramps)

Intersection ID: 13854	Main Street: E_PARK_AV	Cross Street: SOUTH_BV	Location: SE
ADA ID: CEF4EDDFB881	Ramp Type: PerpDiag	Initial Pass/Fail: Fail	Overall Compliance: No
Severity Score: 8.75			
Codes/Mitigation Info/Possible Solution		Field Measurements/Component Compliance

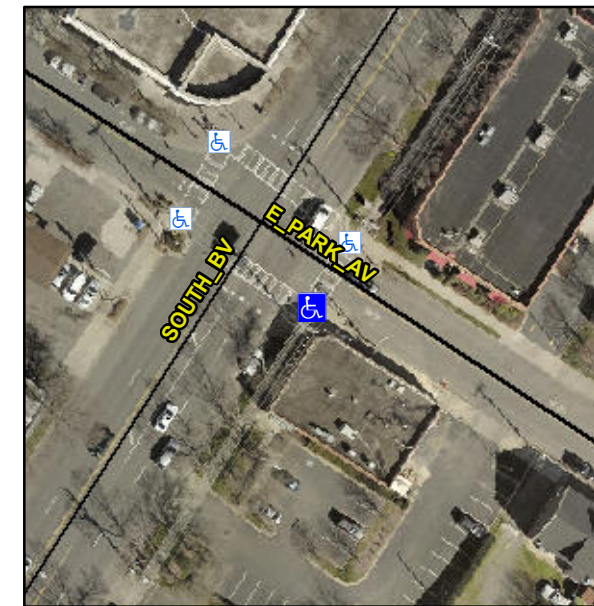
Compliance	Description	Data	Compliance	Description	Data
N/A	Ramp Length (in)	31.0	Yes	Ramp Slope (%)	7.7
No	Ramp Width (in)	45.0	Yes	Ramp XSlope (%)	1.3
N/A	Flare Type LT	N/A	N/A	Flare Type RT	N/A
N/A	Flare Slope LT (%)	N/A	N/A	Flare Slope RT (%)	N/A
N/A	Flare Traversable LT?	N/A	N/A	Flare Traversable RT?	N/A
N/A	Landing Length (in)	N/A	N/A	DWS Provided?	N/A
N/A	Landing Width (in)	N/A	N/A	DWS Contrast?	N/A
N/A	Landing Slope (%)	N/A	N/A	DWS Length (in)	N/A
N/A	Landing X Slope (%)	N/A	N/A	DWS Full Width?	N/A
N/A	Landing Curb? (Y/N)	N/A	N/A	DWS Offset (in)	N/A
N/A	Shared Landing?	N/A			
N/A	Gutter Ponding?	N/A	N/A	Gutter Slope (%)	N/A
N/A	Gutter Lip Ht (in)	N/A	N/A	Gutter X Slope (%)	N/A
N/A	Painted X Walk1?	Yes	N/A	Painted X Walk2?	Yes
	X Walk 1 Direction	To NE		X Walk 2 Direction	To NW
N/A	X Walk 1 Width (in)	108.0	N/A	X Walk 2 Width (in)	107.0
	X Walk 1 Slope (%)	0.5		X Walk 2 Slope (%)	0.1
	X Walk 1 X Slope (%)	0.4		X Walk 2 X Slope (%)	0.5

N/A	Ramp inside XWalk1?	Yes	N/A	Ramp inside XWalk2?	No
	Road Slope (%)	1.3	N/A	Clear Space?	N/A
	Road X Slope (%)	0.7	N/A	Clear Space to XWalk (in)	N/A
N/A	Any Obstructions?	N/A	N/A	Storm Grate/Utility Hazard?	N/A
	Obstruction Type			Storm Grate/Utility Type	
		N/A			N/A
		Yes		Surface Condition? (G/P)	Good

Possible Solutions:

Remove & Replace Curb Ramp With Two New Directional Ramps or Equivalent. Restripe Crosswalk.
