Access Compliance Report

Public Rights-of-Way

(Curb Ramps)

Intersection ID: 10033675	Main Street: ORCHARD LAKE DR	Cross Street: N/A	Location: E
ADA ID: CEFEECB92E9C	Ramp Type: Perp	Initial Pass/Fail: Fail	Overall Compliance: No
Codes/Mitigation Info/Possible Solution		Field Measurements/Component Compliance	
Severity Score: 26.25

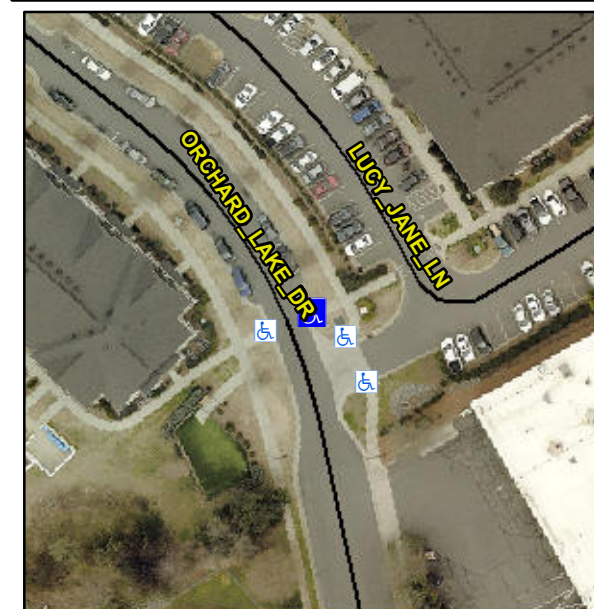
Not Found, R304.2.2, R304.5.3

Compliance	Description	Data	Compliance	Description	Data
N/A	Ramp Length (in)	76.0	No	Ramp Slope (%)	12.2
Yes	Ramp Width (in)	60.0	No	Ramp XSlope (%)	3.3
N/A	Flare Type LT	N/A	N/A	Flare Type RT	N/A
N/A	Flare Slope LT (%)	N/A	N/A	Flare Slope RT (%)	N/A
N/A	Flare Traversable LT?	N/A	N/A	Flare Traversable RT?	N/A
N/A	Landing Length (in)	N/A	N/A	DWS Provided?	N/A
N/A	Landing Width (in)	N/A	N/A	DWS Contrast?	N/A
N/A	Landing Slope (%)	N/A	N/A	DWS Length (in)	N/A
N/A	Landing X Slope (%)	N/A	N/A	DWS Full Width?	N/A
N/A	Landing Curb? (Y/N)	N/A	N/A	DWS Offset (in)	N/A
N/A	Shared Landing?	N/A			
N/A	Gutter Ponding?	N/A	N/A	Gutter Slope (%)	N/A
N/A	Gutter Lip Ht (in)	N/A	N/A	Gutter X Slope (%)	N/A
N/A	Painted X Walk1?	No	N/A	Painted X Walk2?	N/A
	X Walk 1 Direction	To W		X Walk 2 Direction	N/A
N/A	X Walk 1 Width (in)	N/A	N/A	X Walk 2 Width (in)	N/A
	X Walk 1 Slope (%)	0.9		X Walk 2 Slope (%)	N/A
	X Walk 1 X Slope (%)	1.0		X Walk 2 X Slope (%)	N/A

N/A	Ramp inside XWalk1?	N/A	N/A	Ramp inside XWalk2?	N/A
	Road Slope (%)	N/A	N/A	Clear Space?	N/A
	Road X Slope (%)	N/A	N/A	Clear Space to XWalk (in)	N/A
N/A	Any Obstructions?	N/A	N/A	Storm Grate/Utility Hazard?	N/A
	Obstruction Type			Storm Grate/Utility Type	
		N/A			N/A
			Yes	Surface Condition? (G/P)	Good

Possible Solutions:

Remove & Replace Entire Ramp.

Total Cost: \$ 1850.00
