# Access Compliance Report

## Public Rights-of-Way

### (Curb Ramps)

| Intersection ID: 46528 | Main Street: PROSPERITY_CHURCH_RD | Cross Street: ARBOR_CREEK_DR | Location: NE |

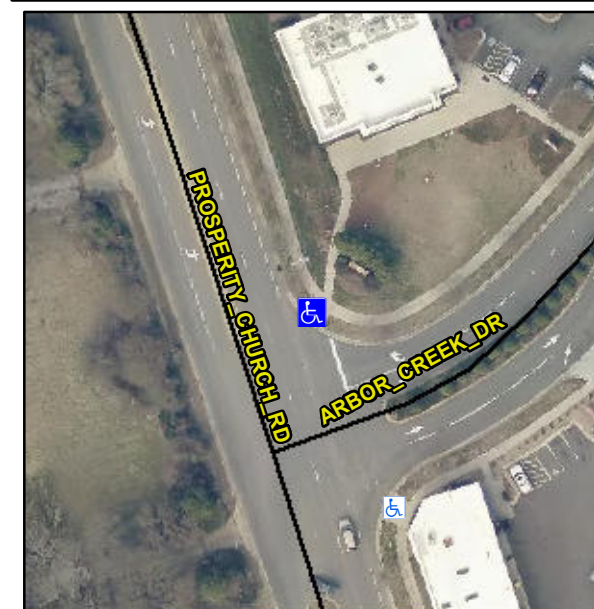
| ADA ID: CF00460E05D5 | Ramp Type: Perp | Initial Pass/Fail: Fail | Overall Compliance: No |
| Severity Score: 10 | | | |

| Compliance | Description | Data | Compliance | Description | Data |
|---|---|---|---|---|---|
| N/A | Ramp Length (in) | 96.0 | Yes | Ramp Slope (%) | 8.0 |
| No | Ramp Width (in) | 40.0 | No | Ramp XSlope (%) | 3.5 |

**Remove & Replace Entire Ramp.**

**R304.5.1, R304.5.3**
