Access Compliance Report Public Rights-of-Way (Curb Ramps)

Location: Intersection ID: 12858 Main Street: AMESBURY AV **Cross Street: ENFIELD RD** NW Ramp Type: Perp Initial Pass/Fail: Fail **Overall Compliance: No ADA ID: CF0102BA4E32 Severity Score:** 8.75

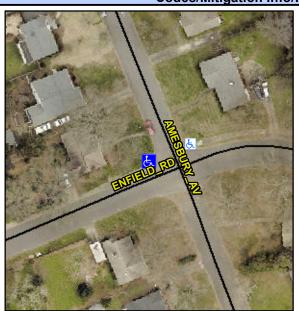
AMESBURY AV Street 1 Name Stop Condition-Street 2 StopSign N/A Street 2 Name Stop Condition-Street 1 N/A Possible Solutions: Remove & Replace Entire Ramp. Surveyor Notes: N/A PROW/ADA: Not Found, R304.5.1
