Intersection ID: 54156	Main Street: OAKDALE_RIDGE_RD	Cross Street: MAPLE_CREEK_CT	Location:	NE
ADA ID: CF067812A110	Ramp Type: Perp	Initial Pass/Fail: Fail	Overall Compliance: No	Severity Score: 8.75

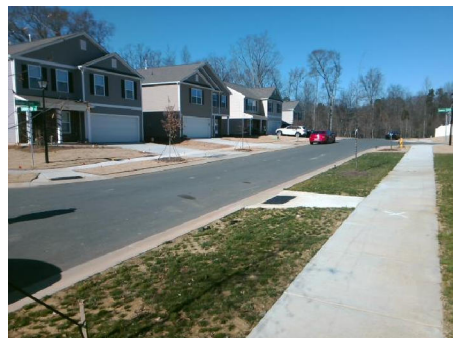
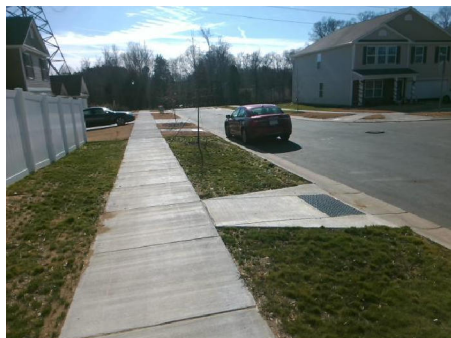
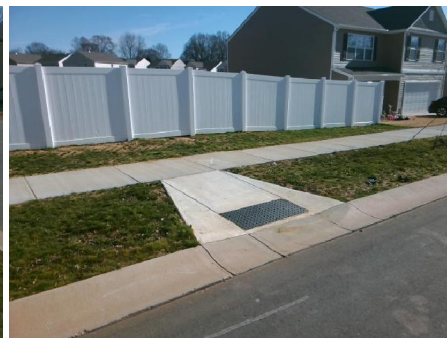
Possible Solutions:			Compliance	Description	Data	Compliance	Description	Data
Remove & Replace Entire Ramp.	N/A	Ramp Length (in)	97.0	Yes	Ramp Slope (%)	7.3		
	No	Ramp Width (in)	47.0	Yes	Ramp XSlope (%)	0.9		
	N/A	Flare Type LT	N/A	N/A	Flare Type RT	N/A		
	N/A	Flare Slope LT (%)	N/A	N/A	Flare Slope RT (%)	N/A		
	N/A	Flare Traversable LT?	N/A	N/A	Flare Traversable RT?	N/A		
	N/A	Landing Length (in)	N/A	N/A	DWS Provided?	N/A		
	N/A	Landing Width (in)	N/A	N/A	DWS Contrast?	N/A		
	N/A	Landing Slope (%)	N/A	N/A	DWS Length (in)	N/A		
	N/A	Landing X Slope (%)	N/A	N/A	DWS Full Width?	N/A		
	N/A	Landing Curb? (Y/N)	N/A	N/A	DWS Offset (in)	N/A		
	N/A	Shared Landing?	N/A					
	N/A	Gutter Ponding?	N/A	N/A	Gutter Slope (%)	N/A		
	N/A	Gutter Lip Ht (in)	N/A	N/A	Gutter X Slope (%)	N/A		
	N/A	Painted X Walk1?	No	N/A	Painted X Walk2?	N/A		
		X Walk 1 Direction	To W		X Walk 2 Direction	N/A		
N/A	X Walk 1 Width (in)	N/A	N/A	X Walk 2 Width (in)	N/A

X Walk 1 Slope (%)	3.6		X Walk 2 Slope (%)	N/A			
	X Walk 1 X Slope (%)	0.9		X Walk 2 X Slope (%)	N/A			
N/A	Ramp inside XWalk1?	N/A	N/A	Ramp inside XWalk2?	N/A			
	Road Slope (%)	N/A	N/A	Clear Space?	N/A			
	Road X Slope (%)	N/A	N/A	Clear Space to XWalk (in)	N/A			
N/A	Any Obstructions?	N/A	N/A	Storm Grate/Utility Hazard?	N/A			
Total Cost:	\$	1850.00		Obstruction Type		Storm Grate/Utility Type		
			N/A			Yes	Surface Condition? (G/P)	Good

Remove & Replace Entire Ramp.
