# Access Compliance Report

## Public Rights-of-Way

### (Curb Ramps)

Intersection ID: N/A	Main Street: 3RD_ST	Cross Street: JOHN_BELK_PY	Location: NW
ADA ID: CF0957E04806	Ramp Type: Perp	Initial Pass/Fail: Fail	Overall Compliance: No
Severity Score: 12.5			
Codes/Mitigation Info/Possible Solution		Field Measurements/Component Compliance

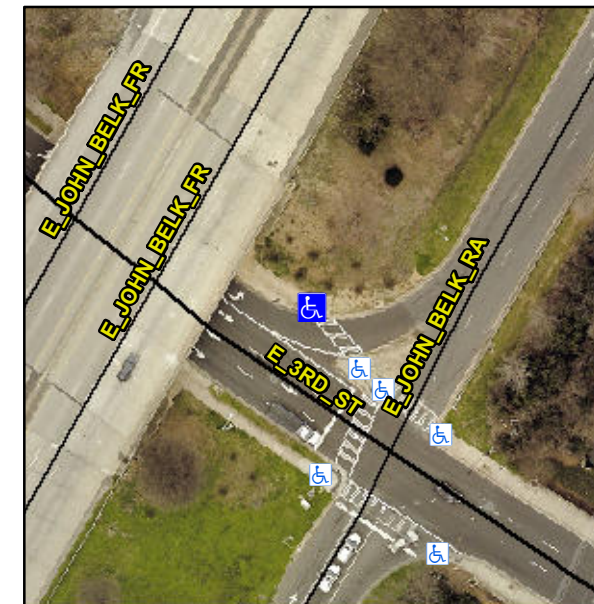
**Not Found, R304.2.2**

Compliance	Description	Data	Compliance	Description	Data
N/A	Ramp Length (in)	64.0	No	Ramp Slope (%)	10.2
Yes	Ramp Width (in)	48.0	Yes	Ramp XSlope (%)	0.8
N/A	Flare Type LT	N/A	N/A	Flare Type RT	N/A
N/A	Flare Slope LT (%)	N/A	N/A	Flare Slope RT (%)	N/A
N/A	Flare Traversable LT?	N/A	N/A	Flare Traversable RT?	N/A
N/A	Landing Length (in)	N/A	N/A	DWS Provided?	N/A
N/A	Landing Width (in)	N/A	N/A	DWS Contrast?	N/A
N/A	Landing Slope (%)	N/A	N/A	DWS Length (in)	N/A
N/A	Landing X Slope (%)	N/A	N/A	DWS Full Width?	N/A
N/A	Landing Curb? (Y/N)	N/A	N/A	DWS Offset (in)	N/A
N/A	Shared Landing?	N/A			
N/A	Gutter Ponding?	N/A	N/A	Gutter Slope (%)	N/A
N/A	Gutter Lip Ht (in)	N/A	N/A	Gutter X Slope (%)	N/A
N/A	Painted X Walk1?	Yes	N/A	Painted X Walk2?	N/A
	X Walk 1 Direction	To SE		X Walk 2 Direction	N/A
N/A	X Walk 1 Width (in)	107.0	N/A	X Walk 2 Width (in)	N/A
	X Walk 1 Slope (%)	2.9		X Walk 2 Slope (%)	N/A
	X Walk 1 X Slope (%)	2.8		X Walk 2 X Slope (%)	N/A

Possible Solutions:

**Remove & Replace Entire Ramp.**

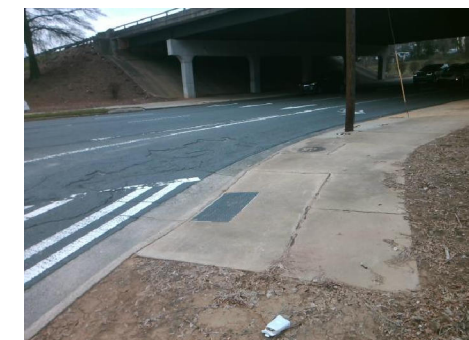
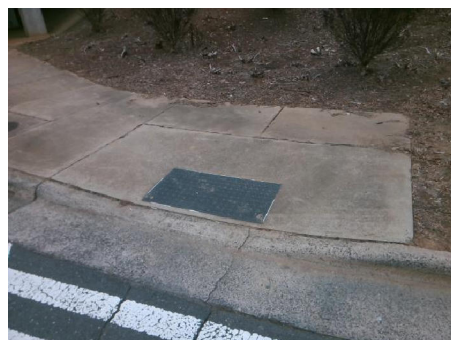
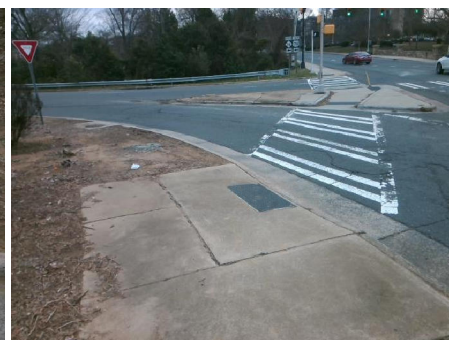
N/A	Ramp inside XWalk1?	Yes	N/A	Ramp inside XWalk2?	N/A
	Road Slope (%)	N/A	N/A	Clear Space?	N/A
	Road X Slope (%)	N/A	N/A	Clear Space to XWalk (in)	N/A
N/A	Any Obstructions?	N/A	N/A	Storm Grate/Utility Hazard?	N/A
	Obstruction Type			Storm Grate/Utility Type	
		N/A			N/A
		Yes		Surface Condition? (G/P)	Good
