Intersection ID: 12646	Main Street: LEVINE AVENUE OF THE ARTS	Cross Street: S TRYON ST	Location:	W
ADA ID: CF0CCB2F2168	Ramp Type: Perp	Initial Pass/Fail: Fail	Overall Compliance: No	Severity Score: 12.5

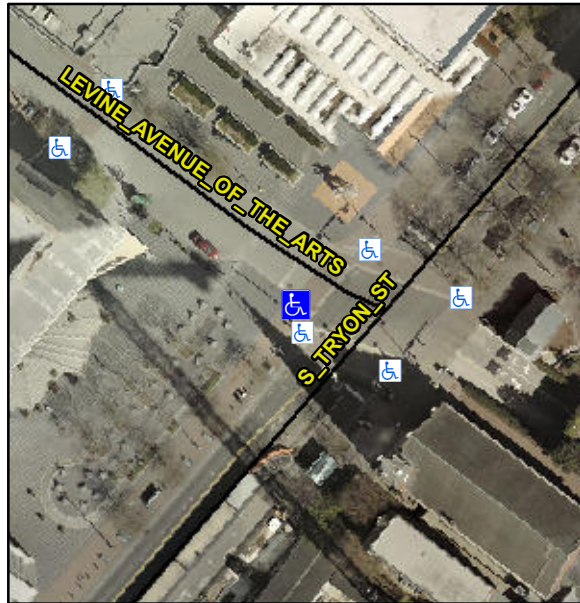
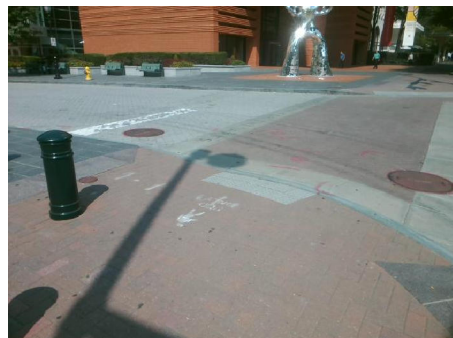
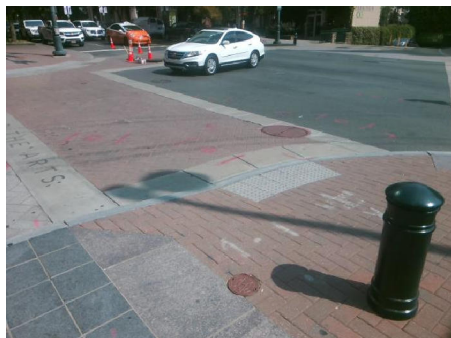
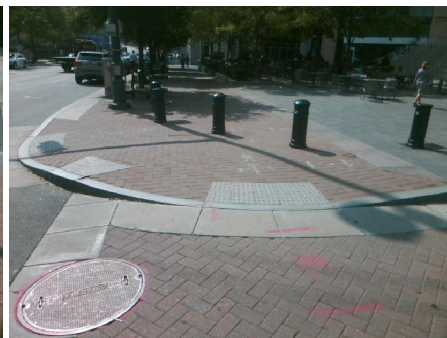
Compliance	Description	Data	Compliance	Description	Data
N/A	Ramp Length (in)	60.0	No	Ramp Slope (%)	10.4
Yes	Ramp Width (in)	60.0	Yes	Ramp XSlope (%)	0.4
N/A	Flare Type LT	N/A	N/A	Flare Type RT	N/A
N/A	Flare Slope LT (%)	N/A	N/A	Flare Slope RT (%)	N/A
N/A	Flare Traversable LT?	N/A	N/A	Flare Traversable RT?	N/A
N/A	Landing Length (in)	N/A	N/A	DWS Provided?	N/A
N/A	Landing Width (in)	N/A	N/A	DWS Contrast?	N/A
N/A	Landing Slope (%)	N/A	N/A	DWS Length (in)	N/A
N/A	Landing X Slope (%)	N/A	N/A	DWS Full Width?	N/A
N/A	Landing Curb? (Y/N)	N/A	N/A	DWS Offset (in)	N/A
N/A	Shared Landing?	N/A			
N/A	Gutter Ponding?	N/A	N/A	Gutter Slope (%)	N/A
N/A	Gutter Lip Ht (in)	N/A	N/A	Gutter X Slope (%)	N/A
N/A	Painted X Walk1?	Yes	N/A	Painted X Walk2?	N/A
	X Walk 1 Direction	To NE		X Walk 2 Direction	N/A
N/A	X Walk 1 Width (in)	139.0	N/A	X Walk 2 Width (in)	N/A
	X Walk 1 Slope (%)	1.8		X Walk 2 Slope (%)	N/A
	X Walk 1 X Slope (%)	2.0		X Walk 2 X Slope (%)	N/A

N/A	Ramp inside XWalk1?	Yes	N/A	Ramp inside XWalk2?	N/A
	Road Slope (%)	N/A	N/A	Clear Space?	N/A
	Road X Slope (%)	N/A	N/A	Clear Space to XWalk (in)	N/A
N/A	Any Obstructions?	N/A	N/A	Storm Grate/Utility Hazard?	N/A
	Obstruction Type			Storm Grate/Utility Type	
		N/A			N/A
			Yes	Surface Condition? (G/P)	Good

Remove & Replace Entire Ramp.

R304.2.2
