Access Compliance Report

Public Rights-of-Way

(Curb Ramps)

Intersection ID: 6811	Main Street: ALTLIFF_CT	Cross Street: WINGDALE_DR	Location:	N
ADA ID: CF0FAA5E0565	Ramp Type: BlendTrans1	Initial Pass/Fail: Fail	Overall Compliance: No	Severity Score: 10

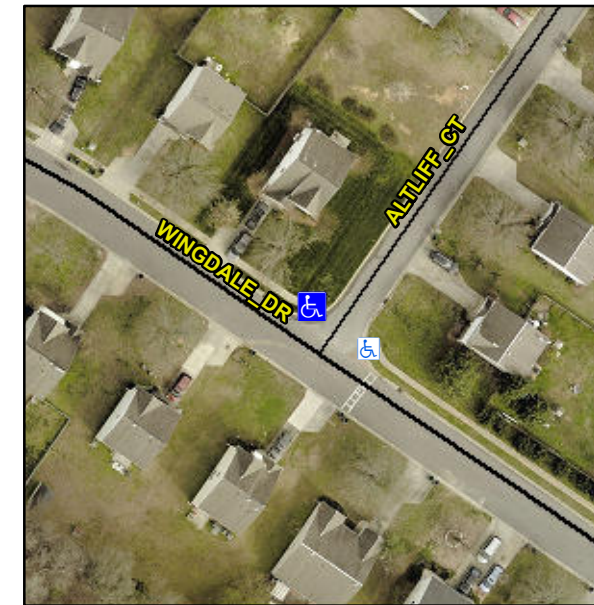
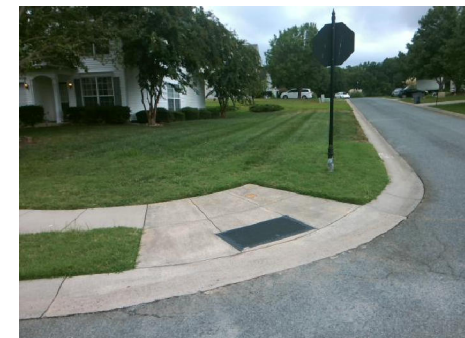
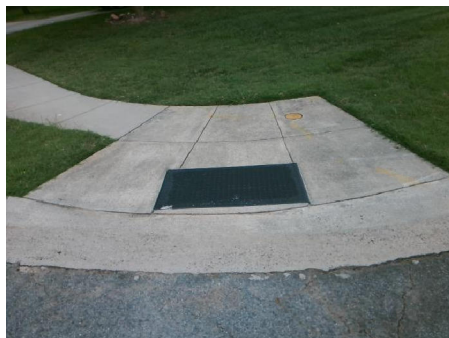
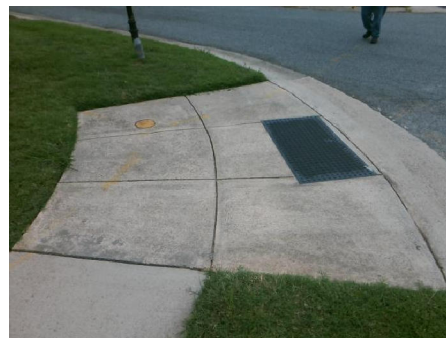
NO RT SW

Not Found, R304.5.1, R304.5.3

Compliance	Description	Data	Compliance	Description	Data
N/A	Ramp Length (in)	50.5	Yes	BlendTrans Slope (%)	3.8
No	Ramp Width (in)	37.5	No	BlendTrans XSlope (%)	4.2
N/A	Flare Type LT	N/A	N/A	Flare Type RT	N/A
N/A	Flare Slope LT (%)	N/A	N/A	Flare Slope RT (%)	N/A
N/A	Flare Traversable LT?	N/A	N/A	Flare Traversable RT?	N/A
N/A	Landing Length (in)	N/A	N/A	DWS Provided?	N/A
N/A	Landing Width (in)	N/A	N/A	DWS Contrast?	N/A
N/A	Landing Slope (%)	N/A	N/A	DWS Length (in)	N/A
N/A	Landing X Slope (%)	N/A	N/A	DWS Full Width?	N/A
N/A	Landing Curb? (Y/N)	N/A	N/A	DWS Offset (in)	N/A
N/A	Shared Landing?	N/A			
N/A	Gutter Ponding?	N/A	N/A	Gutter Slope (%)	N/A
N/A	Gutter Lip Ht (in)	N/A	N/A	Gutter X Slope (%)	N/A
N/A	Painted X Walk1?	No	N/A	Painted X Walk2?	N/A
	X Walk 1 Direction	To SE		X Walk 2 Direction	N/A
	X Walk 1 Width (in)	N/A		X Walk 2 Width (in)	N/A
	X Walk 1 Slope (%)	1.9		X Walk 2 Slope (%)	N/A
	X Walk 1 X Slope (%)	1.2		X Walk 2 X Slope (%)	N/A

N/A	Ramp inside XWalk1?	N/A	N/A	Ramp inside XWalk2?	N/A
	Road Slope (%)	1.2		Clear Space?	N/A
	Road X Slope (%)	1.9	N/A	Clear Space to XWalk (in)	N/A
N/A	Any Obstructions?	N/A	N/A	Storm Grate/Utility Hazard?	N/A
	Obstruction Type			Storm Grate/Utility Type	
		N/A			N/A
			Yes	Surface Condition? (G/P)	Good
			No	Curb Slope (%)	8.2

Remove & Replace Curb Ramp With Two New Directional Ramps or Equivalent.
