## **Access Compliance Report Public Rights-of-Way** (Curb Ramps)

Intersection ID: 10029989 Main Street: LANCASTER HY Cross Street: N/A Location: NE Initial Pass/Fail: Fail **Overall Compliance: No Severity Score:** 12.5 ADA ID: CF10ABA461B9 Ramp Type: ParaDiag

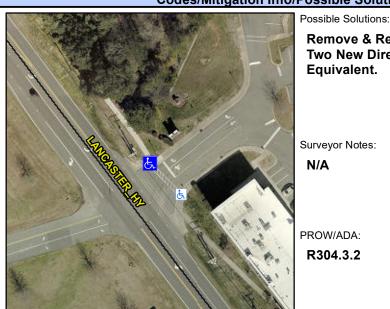
60.0 Yes Yes Ramp Width LT (in) Ramp Width RT (in) No Yes Ramp Slope LT (%) 2.0 Ramp Slope RT (%) Ramp XSlope LT (%) Yes Ramp XSlope RT (%) Yes 1.2 N/A Landing Length (in) N/A N/A DWS Provided? N/A Landing Width (in) N/A N/A **DWS Contrast?** N/A Landing Slope (%) N/A N/A DWS Length (in) N/A Landing X Slope (%) N/A N/A DWS Full Width? N/A Landing Curb? (Y/N) N/A N/A DWS Offset (in) N/A Shared Landing? N/A N/A N/A N/A Gutter Ponding? Gutter Slope (%) N/A Gutter Lip Ht (in) N/A N/A Gutter X Slope (%) N/A Painted X Walk1? No N/A Painted X Walk2? X Walk 1 Direction To W X Walk 2 Direction N/A X Walk 1 Width (in) N/A N/A X Walk 2 Width (in) X Walk 1 Slope (%) 8.5 X Walk 2 Slope (%) X Walk 1 X Slope (%) 3.4 X Walk 2 X Slope (%) Ramp inside XWalk1? N/A N/A N/A Ramp inside XWalk2? 3.6 N/A Road Slope (%) Clear Space? Road X Slope (%) 3.3 N/A Clear Space to XWalk (in) N/A N/A Any Obstructions? N/A Storm Grate/Utility Hazard? Obstruction Type Storm Grate/Utility Type N/A

Street 1 Name Stop Condition-Street 1 Street 2 Name Stop Condition-Street 2 Remove & Replace Curb Ramp With Two New Directional Ramps or Equivalent.

PROW/ADA:

R304.3.2
