Access Compliance Report

Public Rights-of-Way

(Curb Ramps)

Intersection ID: 28945	Main Street: CRESCENT_VIEW_DR	Cross Street: MALLARD_CREEK_RD	Location: SW
ADA ID: CF1C51D4ABF8	Ramp Type: Perp	Initial Pass/Fail: Fail	Overall Compliance: No
Severity Score: 47.5			
Codes/Mitigation Info/Possible Solution		Field Measurements/Component Compliance

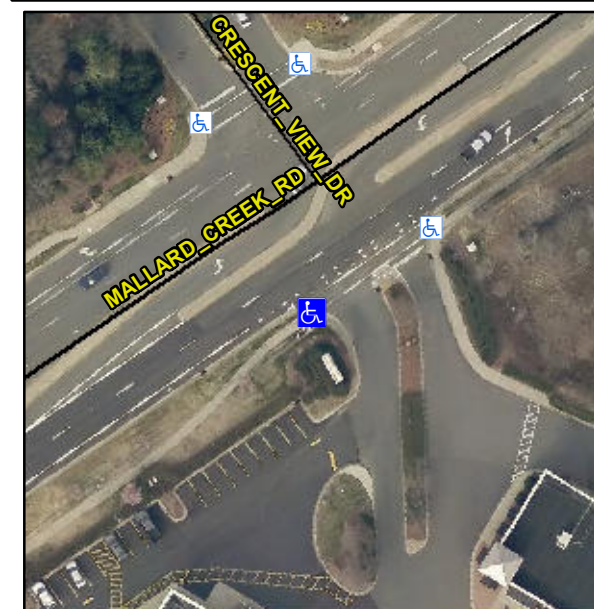
R304.5.1, R304.2.2

Compliance	Description	Data	Compliance	Description	Data
N/A	Ramp Length (in)	78.5	No	Ramp Slope (%)	10.3
No	Ramp Width (in)	28.0	Yes	Ramp XSlope (%)	0.2
N/A	Flare Type LT	N/A	N/A	Flare Type RT	N/A
N/A	Flare Slope LT (%)	N/A	N/A	Flare Slope RT (%)	N/A
N/A	Flare Traversable LT?	N/A	N/A	Flare Traversable RT?	N/A
N/A	Landing Length (in)	N/A	N/A	DWS Provided?	N/A
N/A	Landing Width (in)	N/A	N/A	DWS Contrast?	N/A
N/A	Landing Slope (%)	N/A	N/A	DWS Length (in)	N/A
N/A	Landing X Slope (%)	N/A	N/A	DWS Full Width?	N/A
N/A	Landing Curb? (Y/N)	N/A	N/A	DWS Offset (in)	N/A
N/A	Shared Landing?	N/A			
N/A	Gutter Ponding?	N/A	N/A	Gutter Slope (%)	N/A
N/A	Gutter Lip Ht (in)	N/A	N/A	Gutter X Slope (%)	N/A
N/A	Painted X Walk1?	Yes	N/A	Painted X Walk2?	N/A
	X Walk 1 Direction	To NE		X Walk 2 Direction	N/A
N/A	X Walk 1 Width (in)	81.0	N/A	X Walk 2 Width (in)	N/A
	X Walk 1 Slope (%)	1.0		X Walk 2 Slope (%)	N/A
	X Walk 1 X Slope (%)	3.6		X Walk 2 X Slope (%)	N/A

N/A	Ramp inside XWalk1?	Yes	N/A	Ramp inside XWalk2?	N/A
	Road Slope (%)	N/A	N/A	Clear Space?	N/A
	Road X Slope (%)	N/A	N/A	Clear Space to XWalk (in)	N/A
N/A	Any Obstructions?	N/A	N/A	Storm Grate/Utility Hazard?	N/A
	Obstruction Type			Storm Grate/Utility Type	
		N/A			N/A
			Yes	Surface Condition? (G/P)	Good

Possible Solutions:

Remove & Replace Entire Ramp.

Total Cost: \$ 1850.00
