Access Compliance Report Public Rights-of-Way (Curb Ramps)

Intersection ID: 47141 Main Street: SARANAC_LN Cross Street: DARLINGTON_RD Location: E

ADA ID: CF2146336993 Ramp Type: Perp Initial Pass/Fail: Fail Overall Compliance: No Severity Score: 21.25

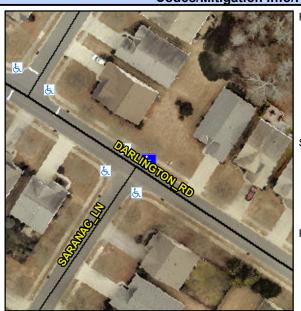
Not Found, R304.5.1, R304.2.2

Field Measurements/Component Compliance						
Compliance Description			Data	Compliance Description		Data
N	I/A	Ramp Length (in)	49.5	No	Ramp Slope (%)	10.3
N	lo	Ramp Width (in)	44.5	Yes	Ramp XSlope (%)	0.8
N	I/A	Flare Type LT	N/A	N/A	Flare Type RT	N/A
N	I/A	Flare Slope LT (%)	N/A	N/A	Flare Slope RT (%)	N/A
N	I/A	Flare Traversable LT?	N/A	N/A	Flare Traversable RT?	N/A
N	I/A	Landing Length (in)	N/A	N/A	DWS Provided?	N/A
N	I/A	Landing Width (in)	N/A	N/A	DWS Contrast?	N/A
N	I/A	Landing Slope (%)	N/A	N/A	DWS Length (in)	N/A
N	I/A	Landing X Slope (%)	N/A	N/A	DWS Full Width?	N/A
N	I/A	Landing Curb? (Y/N)	N/A	N/A	DWS Offset (in)	N/A
N	I/A	Shared Landing?	N/A			
N	I/A	Gutter Ponding?	N/A	N/A	Gutter Slope (%)	N/A
N	I/A	Gutter Lip Ht (in)	N/A	N/A	Gutter X Slope (%)	N/A
N	I/A	Painted X Walk1?	No	N/A	Painted X Walk2?	N/A
		X Walk 1 Direction	To SW		X Walk 2 Direction	N/A
N	I/A	X Walk 1 Width (in)	N/A	N/A	X Walk 2 Width (in)	N/A

Remove & Replace Entire Ramp.
