# Access Compliance Report

## Public Rights-of-Way

### (Curb Ramps)

Intersection ID: 28651	Main Street: MARVIN_RD	Cross Street: PRINCETON_COMMONS_DR	Location: NE
ADA ID: CF3860DBCFA	Ramp Type: Perp	Initial Pass/Fail: Fail	Overall Compliance: No
Severity Score: 61.25			
Codes/Mitigation Info/Possible Solution		Field Measurements/Component Compliance

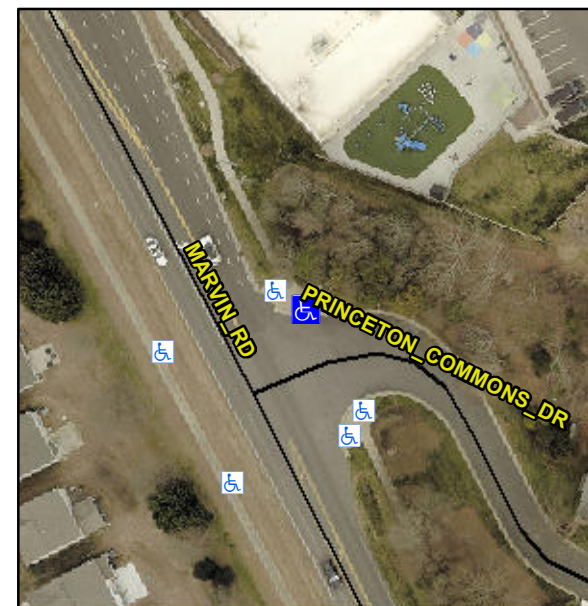
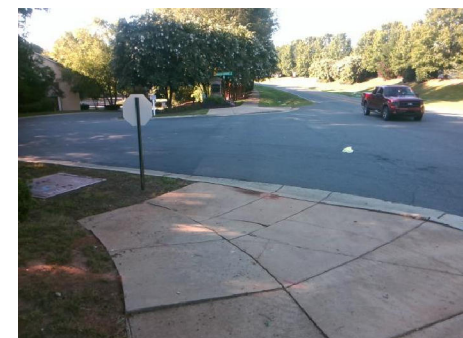
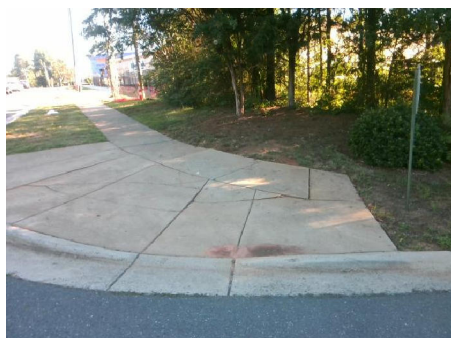
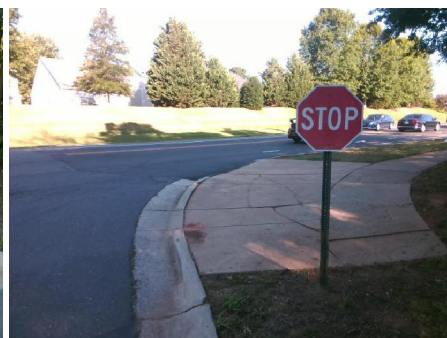
**Not Found, R304.5.1, R304.2.2, R304.5.3, R302.7**

Compliance	Description	Data	Compliance	Description	Data
N/A	Ramp Length (in)	90.0	No	Ramp Slope (%)	13.2
No	Ramp Width (in)	40.0	No	Ramp XSlope (%)	5.3
N/A	Flare Type LT	N/A	N/A	Flare Type RT	N/A
N/A	Flare Slope LT (%)	N/A	N/A	Flare Slope RT (%)	N/A
N/A	Flare Traversable LT?	N/A	N/A	Flare Traversable RT?	N/A
N/A	Landing Length (in)	N/A	N/A	DWS Provided?	N/A
N/A	Landing Width (in)	N/A	N/A	DWS Contrast?	N/A
N/A	Landing Slope (%)	N/A	N/A	DWS Length (in)	N/A
N/A	Landing X Slope (%)	N/A	N/A	DWS Full Width?	N/A
N/A	Landing Curb? (Y/N)	N/A	N/A	DWS Offset (in)	N/A
N/A	Shared Landing?	N/A			
N/A	Gutter Ponding?	N/A	N/A	Gutter Slope (%)	N/A
N/A	Gutter Lip Ht (in)	N/A	N/A	Gutter X Slope (%)	N/A
N/A	Painted X Walk1?	No	N/A	Painted X Walk2?	N/A
	X Walk 1 Direction	To SE		X Walk 2 Direction	N/A
N/A	X Walk 1 Width (in)	N/A	N/A	X Walk 2 Width (in)	N/A
	X Walk 1 Slope (%)	0.8		X Walk 2 Slope (%)	N/A
	X Walk 1 X Slope (%)	4.0		X Walk 2 X Slope (%)	N/A

N/A	Ramp inside XWalk1?	N/A	N/A	Ramp inside XWalk2?	N/A
	Road Slope (%)	N/A	N/A	Clear Space?	N/A
	Road X Slope (%)	N/A	N/A	Clear Space to XWalk (in)	N/A
N/A	Any Obstructions?	N/A	N/A	Storm Grate/Utility Hazard?	N/A
	Obstruction Type			Storm Grate/Utility Type	
		N/A			N/A
		No		Surface Condition? (G/P)	Poor

**Remove & Replace Entire Ramp.**

Total Cost: \$ **1850.00**
