Access Compliance Report

Public Rights-of-Way

(Curb Ramps)

Intersection ID: 44929	Main Street: TWIN_BROOK_DR	Cross Street: NATHAN_DR	Location: SW
ADA ID: CF3DCF2F291C	Ramp Type: Perp	Initial Pass/Fail: Fail	Overall Compliance: No
Severity Score: 8.75			
Codes/Mitigation Info/Possible Solution		Field Measurements/Component Compliance

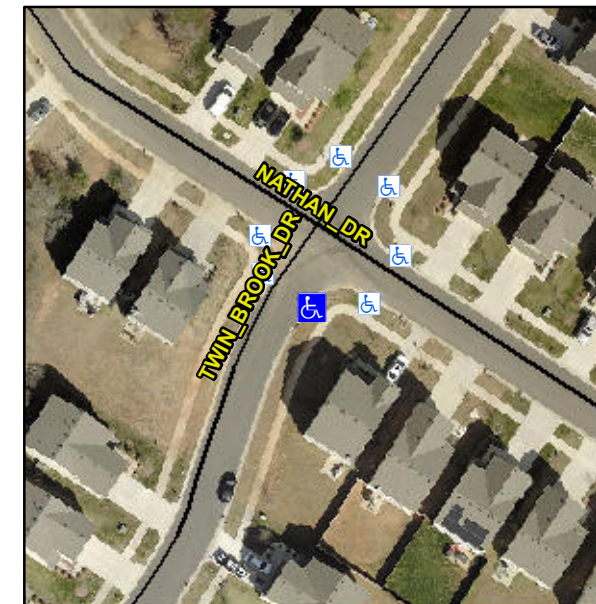
Not Found, R304.5.1

Compliance	Description	Data	Compliance	Description	Data
N/A	Ramp Length (in)	95.5	Yes	Ramp Slope (%)	6.4
No	Ramp Width (in)	38.5	Yes	Ramp XSlope (%)	0.7
N/A	Flare Type LT	N/A	N/A	Flare Type RT	N/A
N/A	Flare Slope LT (%)	N/A	N/A	Flare Slope RT (%)	N/A
N/A	Flare Traversable LT?	N/A	N/A	Flare Traversable RT?	N/A
N/A	Landing Length (in)	N/A	N/A	DWS Provided?	N/A
N/A	Landing Width (in)	N/A	N/A	DWS Contrast?	N/A
N/A	Landing Slope (%)	N/A	N/A	DWS Length (in)	N/A
N/A	Landing X Slope (%)	N/A	N/A	DWS Full Width?	N/A
N/A	Landing Curb? (Y/N)	N/A	N/A	DWS Offset (in)	N/A
N/A	Shared Landing?	N/A			
N/A	Gutter Ponding?	N/A	N/A	Gutter Slope (%)	N/A
N/A	Gutter Lip Ht (in)	N/A	N/A	Gutter X Slope (%)	N/A
N/A	Painted X Walk1?	No	N/A	Painted X Walk2?	N/A
	X Walk 1 Direction	To NW		X Walk 2 Direction	N/A
N/A	X Walk 1 Width (in)	N/A	N/A	X Walk 2 Width (in)	N/A
	X Walk 1 Slope (%)	4.0		X Walk 2 Slope (%)	N/A
	X Walk 1 X Slope (%)	0.4		X Walk 2 X Slope (%)	N/A

N/A	Ramp inside XWalk1?	N/A	N/A	Ramp inside XWalk2?	N/A
	Road Slope (%)	N/A	N/A	Clear Space?	N/A
	Road X Slope (%)	N/A	N/A	Clear Space to XWalk (in)	N/A
N/A	Any Obstructions?	N/A	N/A	Storm Grate/Utility Hazard?	N/A
	Obstruction Type			Storm Grate/Utility Type	
		N/A			N/A
			Yes	Surface Condition? (G/P)	Good

Possible Solutions:

Remove & Replace Entire Ramp.
