Access Compliance Report

Public Rights-of-Way

(Curb Ramps)

Intersection ID: 27190	Main Street: BALLANTYNE_COMMONS_PY	Cross Street: WOODVIEW_CR	Location: NE
ADA ID: CF3FFCB1CDD5	Ramp Type: Directional1	Initial Pass/Fail: Fail	Overall Compliance: No
Severity Score: 12.5			
Codes/Mitigation Info/Possible Solution		Field Measurements/Component Compliance

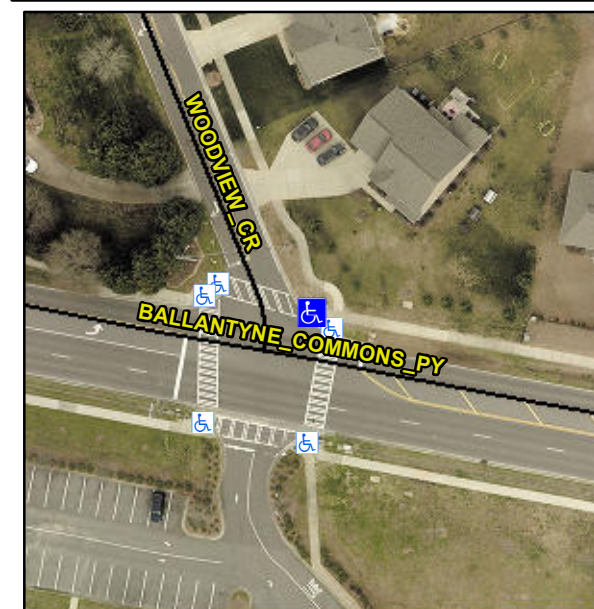
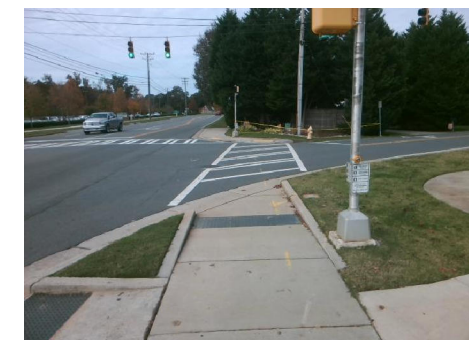
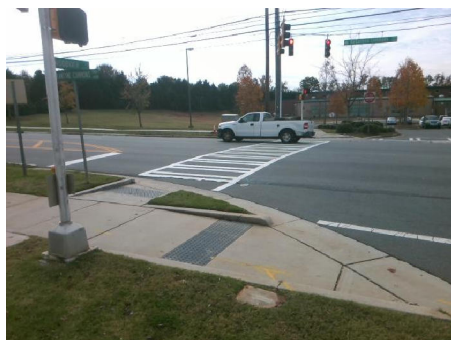
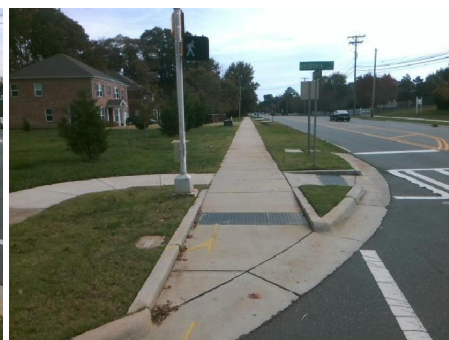
Compliance	Description	Data	Compliance	Description	Data
N/A	Ramp Length (in)	103.0	N/A	Grade Break?	N/A
Yes	Ramp Width (in)	72.0	N/A	Grade Break Slope (%)	0.0
No	Ramp Slope (%)	8.7	N/A	Grade Break XSlope (%)	0.0
Yes	Ramp XSlope (%)	1.6			
N/A	Flare Type LT	N/A	N/A	Flare Type RT	N/A
N/A	Flare Slope LT (%)	N/A	N/A	Flare Slope RT (%)	0.0
N/A	Flare Traversable LT?	N/A	N/A	Flare Traversable RT?	N/A
N/A	Landing Length (in)	0.0	N/A	DWS Provided?	N/A
N/A	Landing Width (in)	0.0	N/A	DWS Contrast?	N/A
N/A	Landing Slope (%)	0.0	N/A	DWS Length (in)	N/A
N/A	Landing X Slope (%)	0.0	N/A	DWS Full Width?	N/A
N/A	Landing Curb? (Y/N)	N/A	N/A	DWS Offset LT (in)	N/A
N/A	Shared Landing?	N/A	N/A	DWS Offset RT (in)	N/A
N/A	Gutter Ponding?	0.0	N/A	Gutter Slope (%)	N/A
N/A	Gutter Lip Ht (in)	0.0	N/A	Gutter X Slope (%)	N/A
N/A	Painted X Walk1?	Yes		Road Slope (%)	2.2
	X Walk 1 Direction	To W		Road X Slope (%)	0.4
	X Walk 1 Width (in)	110.0		Clear Space?	N/A

X Walk 1 Slope (%)	2.2	N/A	Clear Space to XWalk (in)	N/A
	X Walk 1 X Slope (%)	0.4	N/A	Storm Grate/Utility Hazard?	N/A
N/A	Ramp inside XWalk1?	Yes		Storm Grate/Utility Type	
N/A	Any Obstructions?	N/A			N/A
	Obstruction Type		Yes	Surface Condition? (G/P)	Good
			N/A	Curb Slope (%)	1.5

Possible Solutions:

Remove & Replace Entire Ramp.

R304.2.2
