# Access Compliance Report

## Public Rights-of-Way

### (Curb Ramps)

Intersection ID: 50619	Main Street: COTTON_GUM_RD	Cross Street: YELLOW_OAK_RD	Location: NE
ADA ID: CF400D4F1E1F	Ramp Type: Perp	Initial Pass/Fail: Fail	Overall Compliance: No
		Severity Score: 25

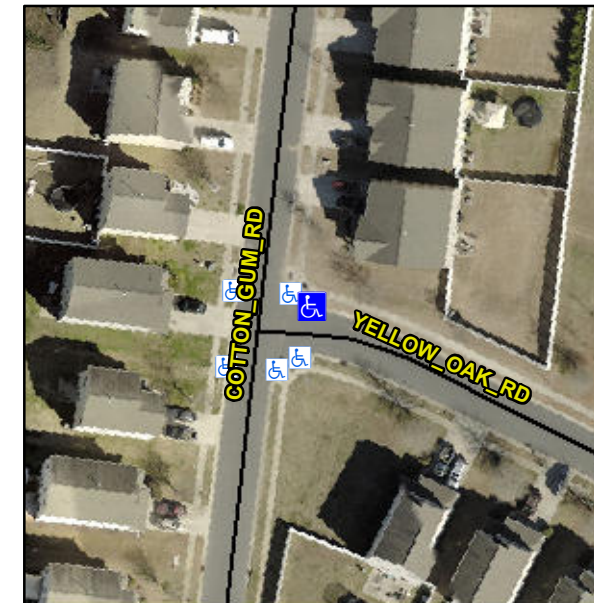
**Not Found, R304.2.2**

Compliance	Description	Data	Compliance	Description	Data
N/A	Ramp Length (in)	49.0	No	Ramp Slope (%)	18.1
Yes	Ramp Width (in)	48.0	Yes	Ramp XSlope (%)	2.0
N/A	Flare Type LT	N/A	N/A	Flare Type RT	N/A
N/A	Flare Slope LT (%)	N/A	N/A	Flare Slope RT (%)	N/A
N/A	Flare Traversable LT?	N/A	N/A	Flare Traversable RT?	N/A
N/A	Landing Length (in)	N/A	N/A	DWS Provided?	N/A
N/A	Landing Width (in)	N/A	N/A	DWS Contrast?	N/A
N/A	Landing Slope (%)	N/A	N/A	DWS Length (in)	N/A
N/A	Landing X Slope (%)	N/A	N/A	DWS Full Width?	N/A
N/A	Landing Curb? (Y/N)	N/A	N/A	DWS Offset (in)	N/A
N/A	Shared Landing?	N/A			
N/A	Gutter Ponding?	N/A	N/A	Gutter Slope (%)	N/A
N/A	Gutter Lip Ht (in)	N/A	N/A	Gutter X Slope (%)	N/A
N/A	Painted X Walk1?	No	N/A	Painted X Walk2?	N/A
	X Walk 1 Direction	To S		X Walk 2 Direction	N/A
N/A	X Walk 1 Width (in)	N/A	N/A	X Walk 2 Width (in)	N/A
	X Walk 1 Slope (%)	2.1		X Walk 2 Slope (%)	N/A
	X Walk 1 X Slope (%)	1.7		X Walk 2 X Slope (%)	N/A

**Remove & Replace Entire Ramp.**

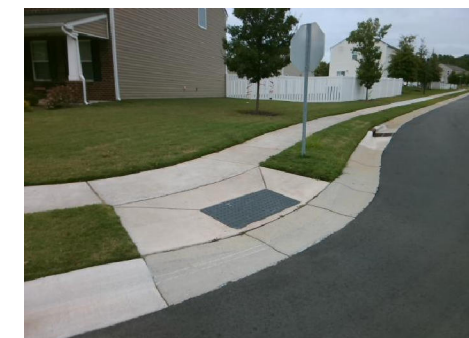
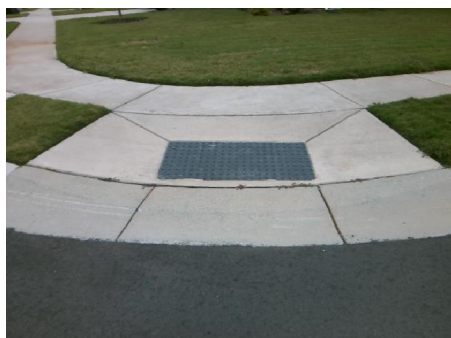
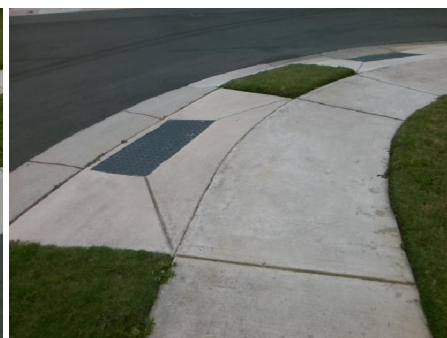
N/A	Ramp inside XWalk1?	N/A	N/A	Ramp inside XWalk2?	N/A
	Road Slope (%)	N/A	N/A	Clear Space?	N/A
	Road X Slope (%)	N/A	N/A	Clear Space to XWalk (in)	N/A
N/A	Any Obstructions?	N/A	N/A	Storm Grate/Utility Hazard?	N/A
	Obstruction Type			Storm Grate/Utility Type	
		N/A			N/A
			Yes	Surface Condition? (G/P)	Good
