Access Compliance Report

Public Rights-of-Way

(Curb Ramps)

Intersection ID: 10036601	Main Street: RUSHMORE_DR	Cross Street: N/A	Location: NE
ADA ID: CF467CC0D110	Ramp Type: PerpDiag	Initial Pass/Fail: Fail	Overall Compliance: No
		Severity Score: 35

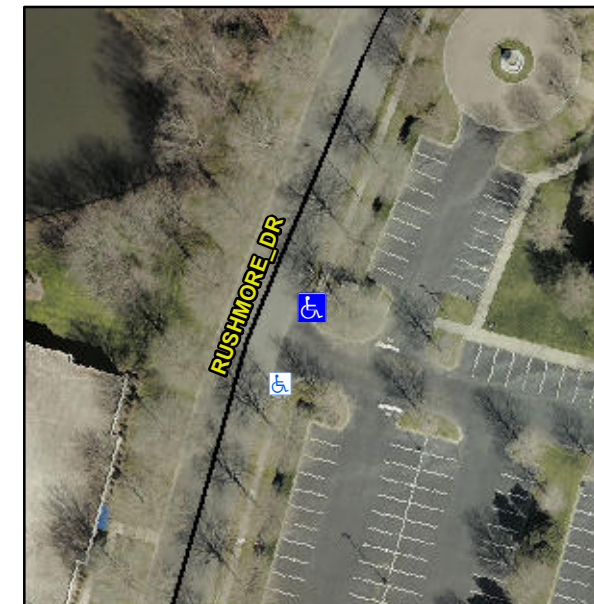
Not Found, R304.5.1, R304.2.2, R304.5.3

Compliance	Description	Data	Compliance	Description	Data
N/A	Ramp Length (in)	49.0	No	Ramp Slope (%)	15.7
No	Ramp Width (in)	46.0	No	Ramp XSlope (%)	3.2
N/A	Flare Type LT	N/A	N/A	Flare Type RT	N/A
N/A	Flare Slope LT (%)	N/A	N/A	Flare Slope RT (%)	N/A
N/A	Flare Traversable LT?	N/A	N/A	Flare Traversable RT?	N/A
N/A	Landing Length (in)	N/A	N/A	DWS Provided?	N/A
N/A	Landing Width (in)	N/A	N/A	DWS Contrast?	N/A
N/A	Landing Slope (%)	N/A	N/A	DWS Length (in)	N/A
N/A	Landing X Slope (%)	N/A	N/A	DWS Full Width?	N/A
N/A	Landing Curb? (Y/N)	N/A	N/A	DWS Offset (in)	N/A
N/A	Shared Landing?	N/A			
N/A	Gutter Ponding?	N/A	N/A	Gutter Slope (%)	N/A
N/A	Gutter Lip Ht (in)	N/A	N/A	Gutter X Slope (%)	N/A
N/A	Painted X Walk1?	No	N/A	Painted X Walk2?	No
	X Walk 1 Direction	To NW		X Walk 2 Direction	To SW
N/A	X Walk 1 Width (in)	N/A	N/A	X Walk 2 Width (in)	N/A
	X Walk 1 Slope (%)	3.9		X Walk 2 Slope (%)	1.3
	X Walk 1 X Slope (%)	0.6		X Walk 2 X Slope (%)	5.5

N/A	Ramp inside XWalk1?	N/A	N/A	Ramp inside XWalk2?	N/A
	Road Slope (%)	3.2	N/A	Clear Space?	N/A
	Road X Slope (%)	3.2	N/A	Clear Space to XWalk (in)	N/A
N/A	Any Obstructions?	N/A	N/A	Storm Grate/Utility Hazard?	N/A
	Obstruction Type			Storm Grate/Utility Type	
		N/A			N/A
			Yes	Surface Condition? (G/P)	Good

Remove & Replace Curb Ramp With Two New Directional Ramps or Equivalent.
