Access Compliance Report Public Rights-of-Way (Curb Ramps)

Intersection ID: 6586Main Street: ARVIN_DRCross Street: ATLAS_DRLocation:SEADA ID: CF46F9E95AF8Ramp Type: PerpInitial Pass/Fail: FailOverall Compliance: NoSeverity Score:12.5

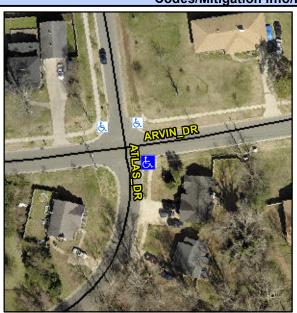
Field Measurements/Component Compliance						
Comp	liance Description	Data	Comp	liance	Description	Data
N/A	Ramp Length (in)	94.0	Yes	Ramp	Slope (%)	6.3
Yes	Ramp Width (in)	48.0	No	Ramp	XSlope (%)	5.2
N/A	Flare Type LT	N/A	N/A	Flare	Type RT	N/A
N/A	Flare Slope LT (%)	N/A	N/A	Flare	Slope RT (%)	N/A
N/A	Flare Traversable LT?	N/A	N/A	Flare	Traversable RT?	N/A
N/A	Landing Length (in)	N/A	N/A	DWS	Provided?	N/A
N/A	Landing Width (in)	N/A	N/A	DWS	Contrast?	N/A
N/A	Landing Slope (%)	N/A	N/A	DWS	Length (in)	N/A
N/A	Landing X Slope (%)	N/A	N/A	DWS	Full Width?	N/A
N/A	Landing Curb? (Y/N)	N/A	N/A	DWS	Offset (in)	N/A
N/A	Shared Landing?	N/A				
N/A	Gutter Ponding?	N/A	N/A	Gutte	r Slope (%)	N/A
N/A	Gutter Lip Ht (in)	N/A	N/A	Gutte	r X Slope (%)	N/A
N/A	Painted X Walk1?	No	N/A	Paint	ed X Walk2?	N/A
	X Walk 1 Direction	To N		X Wa	lk 2 Direction	N/A
N/A	X Walk 1 Width (in)	N/A	N/A	X Wa	lk 2 Width (in)	N/A
	X Walk 1 Slope (%)	1.6		X Wa	lk 2 Slope (%)	N/A

X Walk 1 X Slope (%)	2.8		X Wa	lk 2 X Slope (%)	N/A
N/A	Ramp inside XWalk1?	N/A	N/A	Ram	inside XWalk2?	N/A
	Road Slope (%)	N/A	N/A	Clear	Space?	N/A
	Road X Slope (%)	N/A	N/A	Clear	Space to XWalk (in)	N/A
N/A	Any Obstructions?	N/A	N/A	Storn	n Grate/Utility Hazard?	N/A
	Obstruction Type			Storn	n Grate/Utility Type	
		N/A				N/A
4 1			Yes	Surfa	ce Condition? (G/P)	Good

i ossible solution	
Possible Solutions:	Con
Remove & Replace Entire Ramp.	N/A
•	Yes
	N/A
	N/A
	N/A
	N/A
Surveyor Notes:	N/A
N/A	N/A
	N/A
	N/A
	N/A
PROW/ADA:	N/A
Not Found, R304.5.3	N/A
	N/A
	N/A
	N/A
