# Access Compliance Report

## Public Rights-of-Way

### (Curb Ramps)

Intersection ID: 44699	Main Street: STILLGREEN_LN	Cross Street: BIRCHWOOD_DR	Location: S
ADA ID: CF47F42D2D1F	Ramp Type: Perp	Initial Pass/Fail: Fail	Overall Compliance: No
Codes/Mitigation Info/Possible Solution			Severity Score: 30
			Field Measurements/Component Compliance

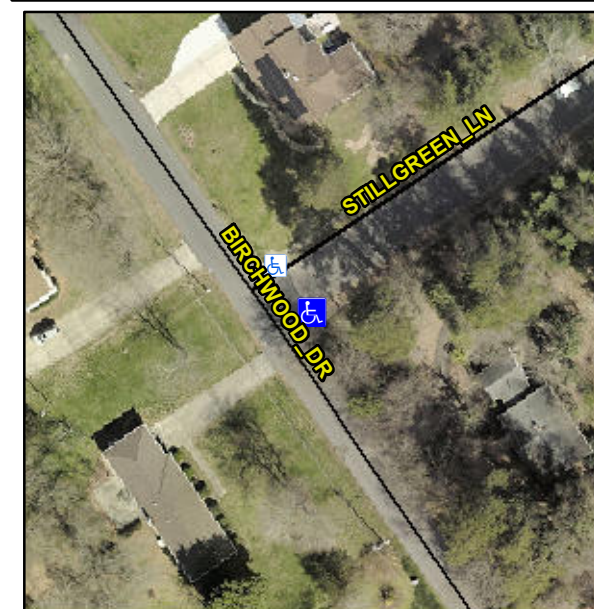
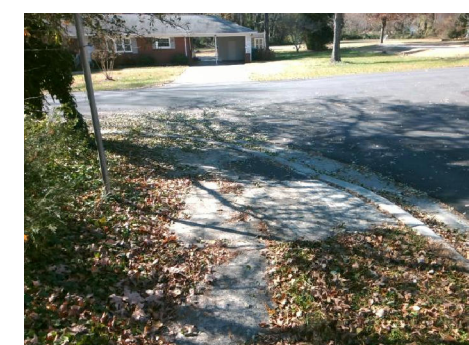
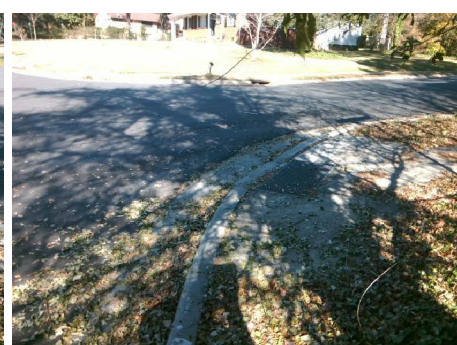
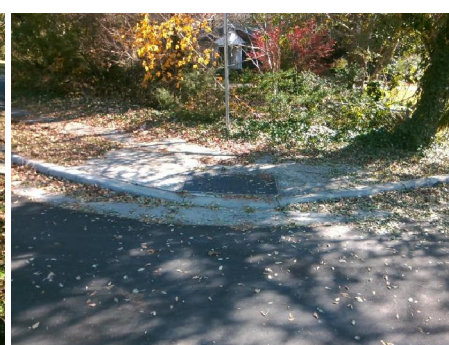
**Not Found, R304.5.1, R304.5.3**

Compliance	Description	Data	Compliance	Description	Data
N/A	Ramp Length (in)	47.0	Yes	Ramp Slope (%)	7.7
No	Ramp Width (in)	33.0	No	Ramp XSlope (%)	6.1
N/A	Flare Type LT	N/A	N/A	Flare Type RT	N/A
N/A	Flare Slope LT (%)	N/A	N/A	Flare Slope RT (%)	N/A
N/A	Flare Traversable LT?	N/A	N/A	Flare Traversable RT?	N/A
N/A	Landing Length (in)	N/A	N/A	DWS Provided?	N/A
N/A	Landing Width (in)	N/A	N/A	DWS Contrast?	N/A
N/A	Landing Slope (%)	N/A	N/A	DWS Length (in)	N/A
N/A	Landing X Slope (%)	N/A	N/A	DWS Full Width?	N/A
N/A	Landing Curb? (Y/N)	N/A	N/A	DWS Offset (in)	N/A
N/A	Shared Landing?	N/A			
N/A	Gutter Ponding?	N/A	N/A	Gutter Slope (%)	N/A
N/A	Gutter Lip Ht (in)	0.5	N/A	Gutter X Slope (%)	N/A
N/A	Painted X Walk1?	No	N/A	Painted X Walk2?	N/A
	X Walk 1 Direction	To NW		X Walk 2 Direction	N/A
N/A	X Walk 1 Width (in)	N/A	N/A	X Walk 2 Width (in)	N/A
	X Walk 1 Slope (%)	4.8		X Walk 2 Slope (%)	N/A
	X Walk 1 X Slope (%)	4.6		X Walk 2 X Slope (%)	N/A

N/A	Ramp inside XWalk1?	N/A	N/A	Ramp inside XWalk2?	N/A
	Road Slope (%)	N/A	N/A	Clear Space?	N/A
	Road X Slope (%)	N/A	N/A	Clear Space to XWalk (in)	N/A
N/A	Any Obstructions?	N/A	N/A	Storm Grate/Utility Hazard?	N/A
	Obstruction Type			Storm Grate/Utility Type	
		N/A			N/A
			Yes	Surface Condition? (G/P)	Good

**Remove & Replace Entire Ramp.**

Total Cost: \$ 1850.00
